# **Arson Attack & Airstrikes at Community Near Zamzam IDP Camp**

14 February 2025

# Community North of Zamzam IDP Camp

MUNITION IMPACT, THERMAL SCARRING, AND  
DAMAGE TO STRUCTURES OBSERVED BETWEEN  
13-14 FEBRUARY 2025

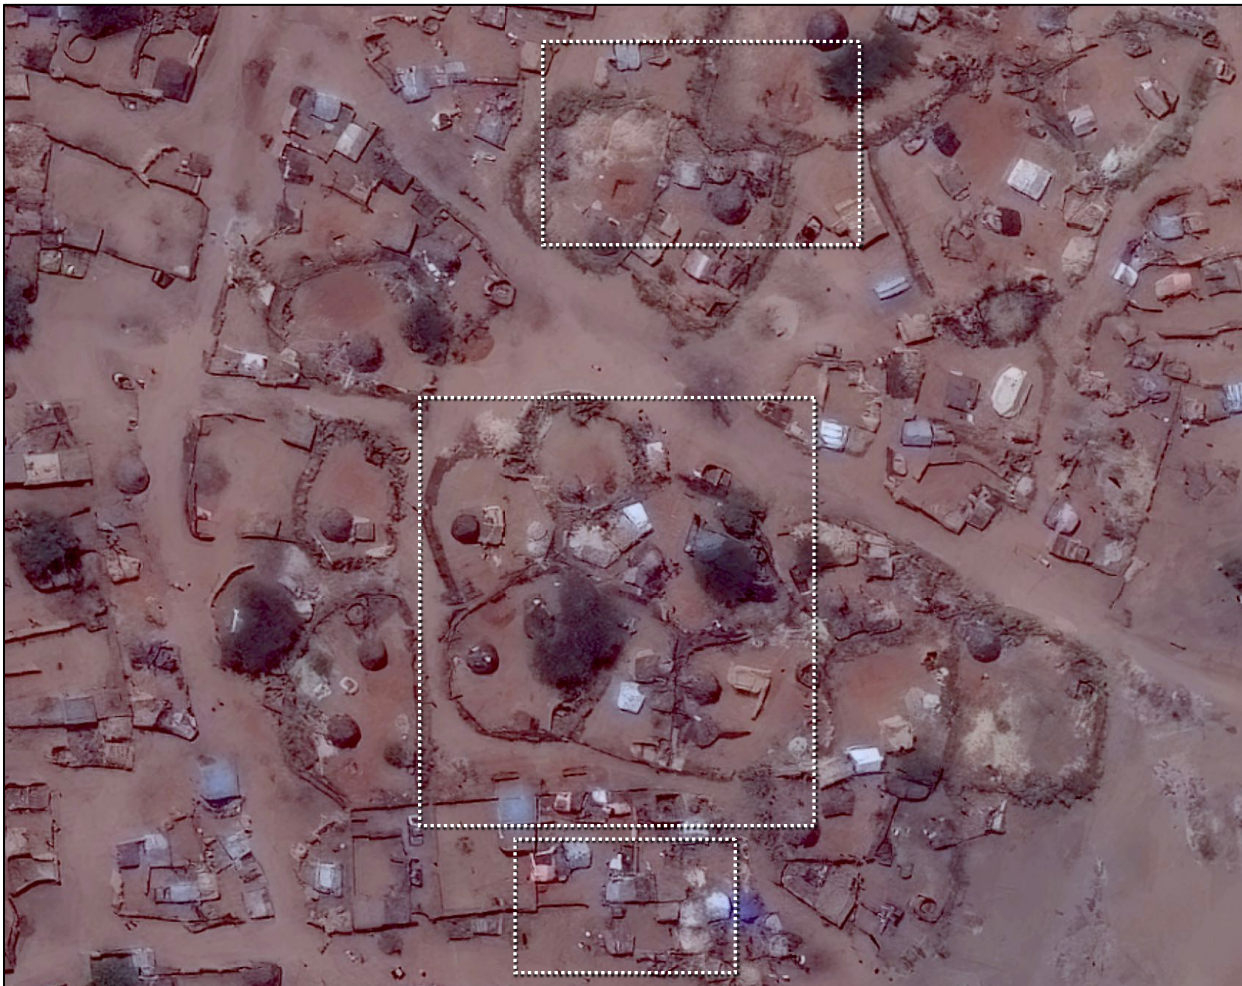
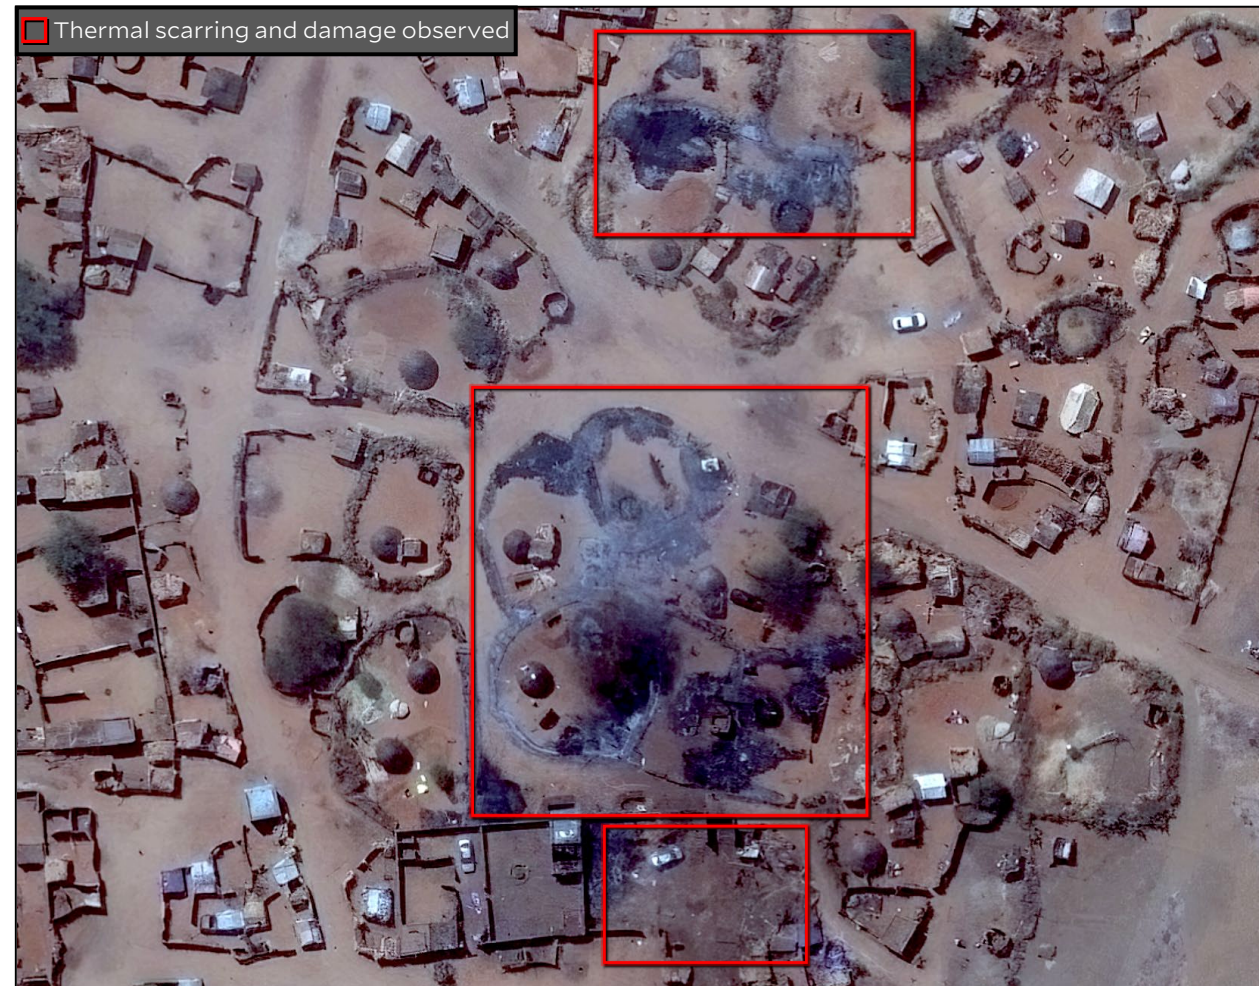
Analysis of satellite imagery collected between 13 and 14 February 2025 of a community 2.5 km north of Zamzam shows the new presence of a munition impact, thermal scarring, and damage to structures.

13 February 2025 © 2025 Maxar Technologies  
Image enhanced with MGP Pro HD image enhancement

14 February 2025 © 2025 Maxar Technologies  
Image enhanced with MGP Pro HD image enhancement

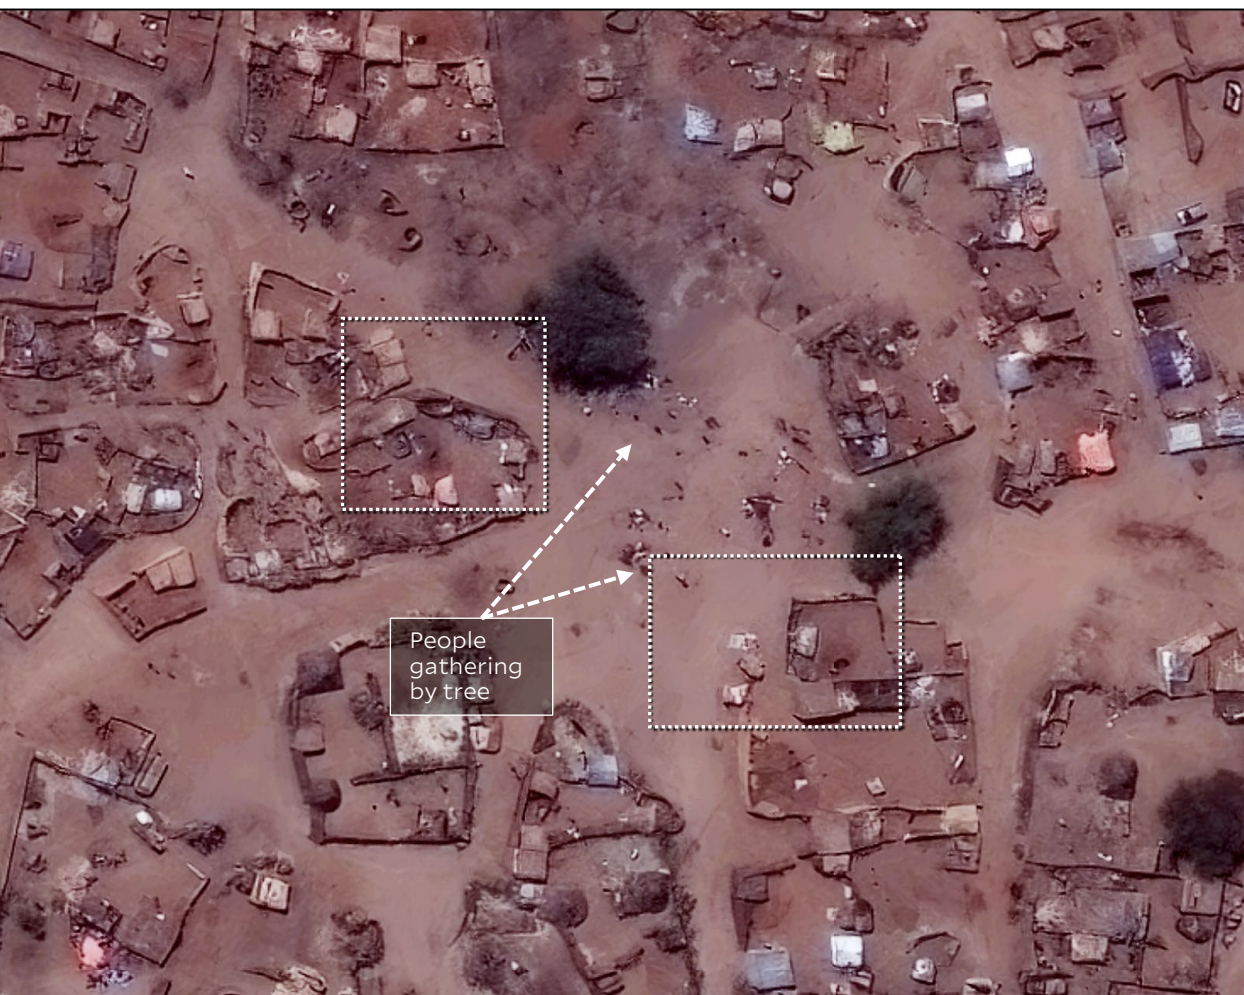
## MUNITION IMPACTS AND DAMAGE TO STRUCTURES OBSERVED BETWEEN 13-14 FEBRUARY 2025

13 February 2025 © 2025 Maxar Technologies  
Image enhanced with MGP Pro HD image enhancement

Analysis of satellite imagery collected between 13 and 14 February 2025 of a community 2.5 km north of Zamzam shows the new presence of a munition impact and damage to structures.

Analysis of archival imagery shows the presence of people regularly gathering in this location. This location may serve as a water point, distribution site, or other civilian gathering area.

14 February 2025 © 2025 Maxar Technologies  
Image enhanced with MGP Pro HD image enhancement

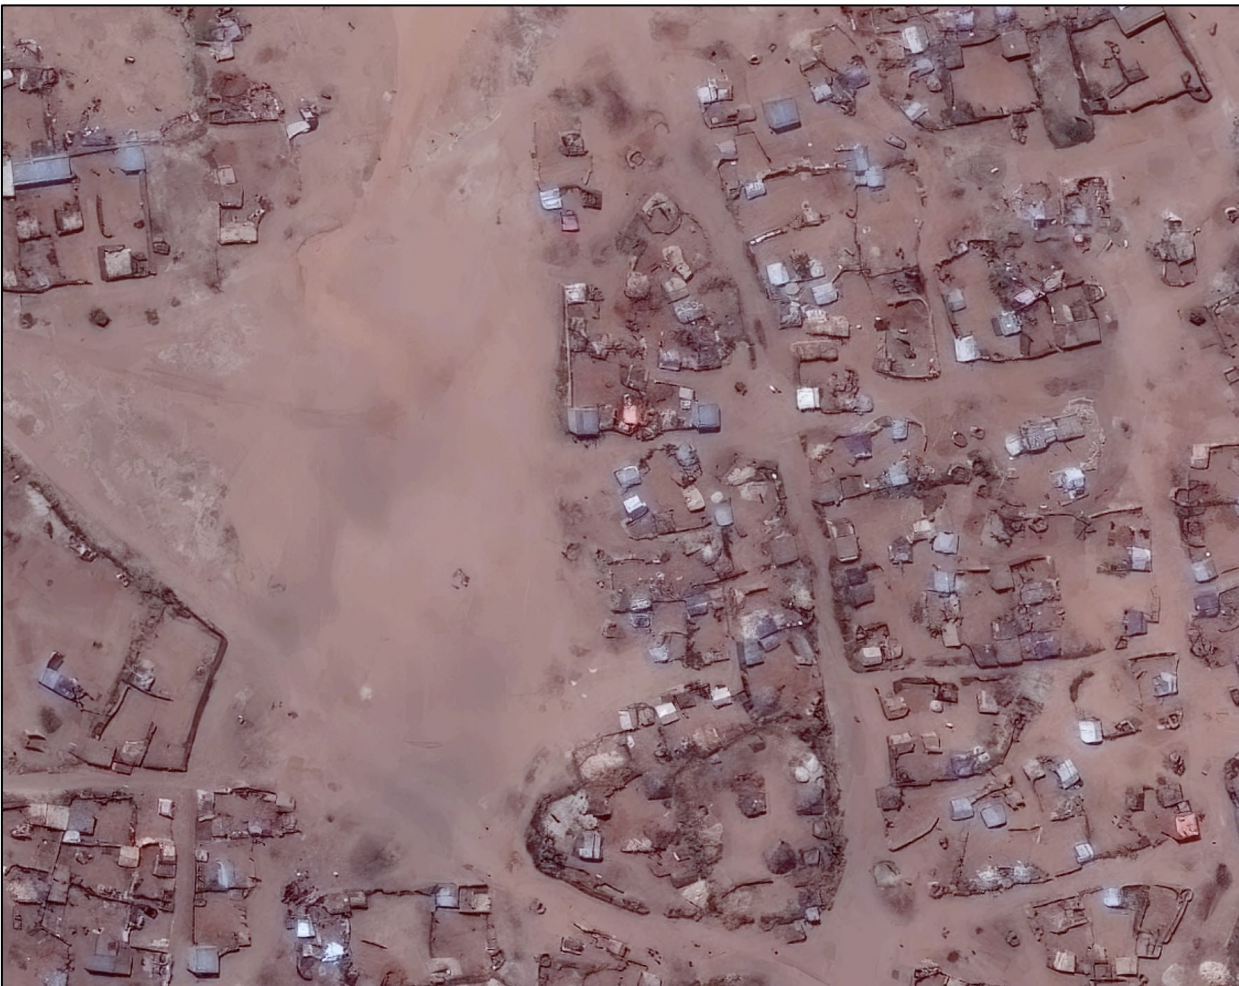
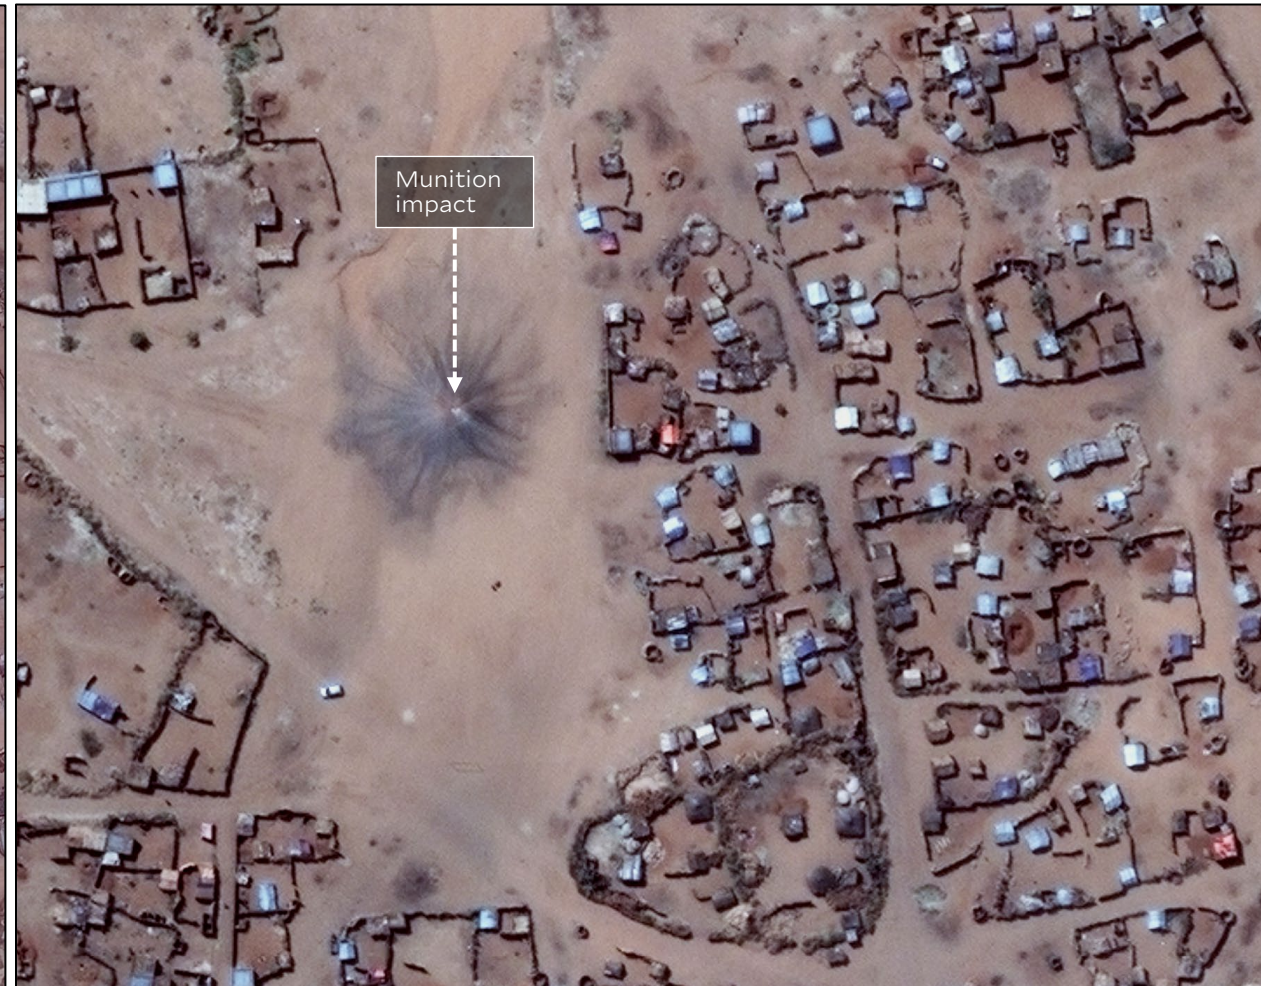
MUNITION IMPACT OBSERVED BETWEEN  
13-14 FEBRUARY 2025

Analysis of satellite imagery collected between 13 and 14 February 2025 of a community 2.5 km north of Zamzam shows the new presence of a munition impact on the southern side of the community.

13 February 2025 © 2025 Maxar Technologies  
Image enhanced with MGP Pro HD image enhancement

14 February 2025 © 2025 Maxar Technologies  
Image enhanced with MGP Pro HD image enhancement

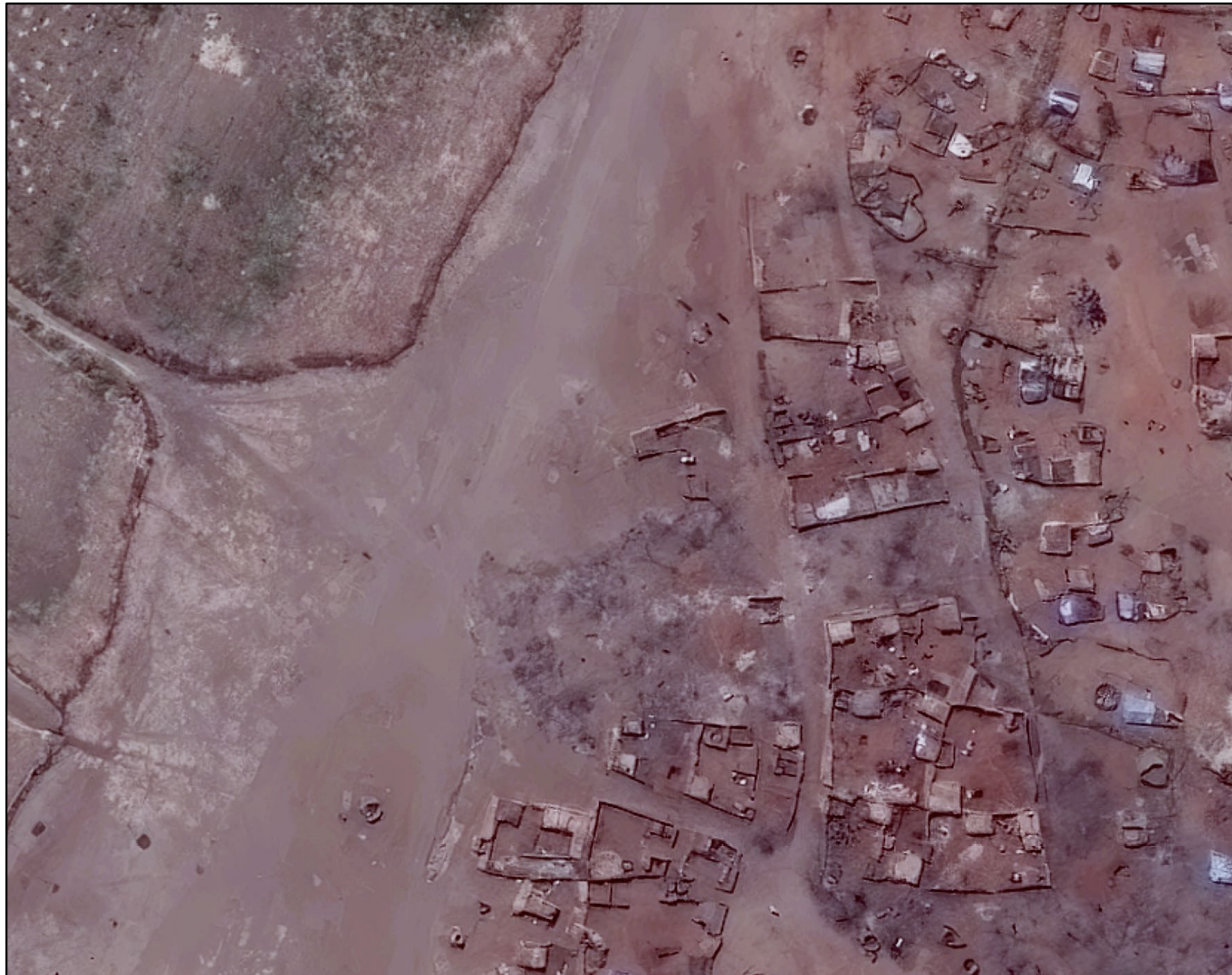
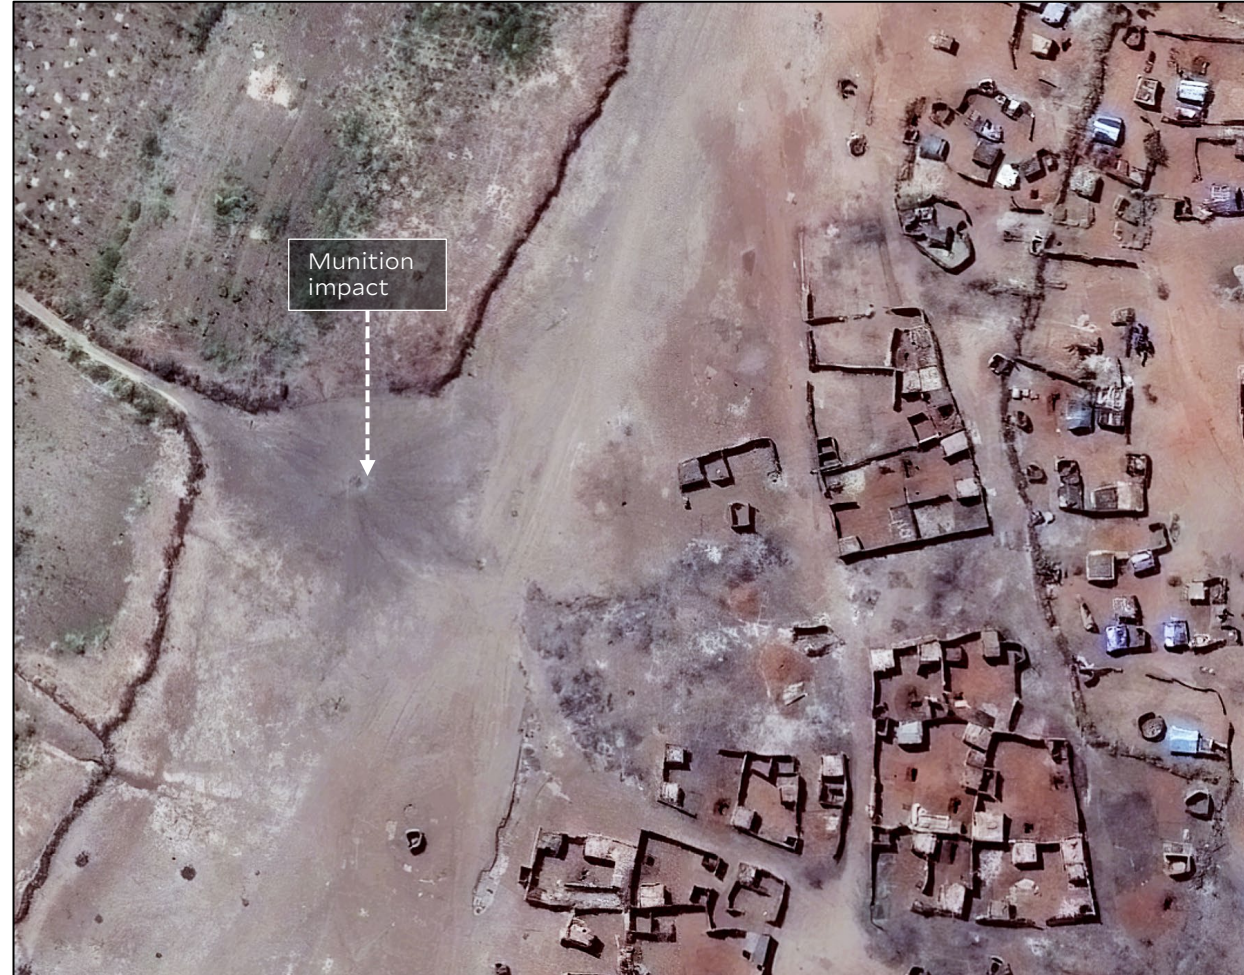
MUNITION IMPACT OBSERVED BETWEEN  
13-14 FEBRUARY 2025

Analysis of satellite imagery collected between 13 and 14 February 2025 of a community 2.5 km north of Zamzam shows the new presence of a munition impact on the eastern side of the community.

13 February 2025 © 2025 Maxar Technologies  
Image enhanced with MGP Pro HD image enhancement

14 February 2025 © 2025 Maxar Technologies  
Image enhanced with MGP Pro HD image enhancement
