Ukraine's Crop Storage Infrastructure: Post-Invasion Impact Assessment

15 September 2022

Yale SCHOOL OF PUBLIC HEALTH
Humanitarian Research Lab

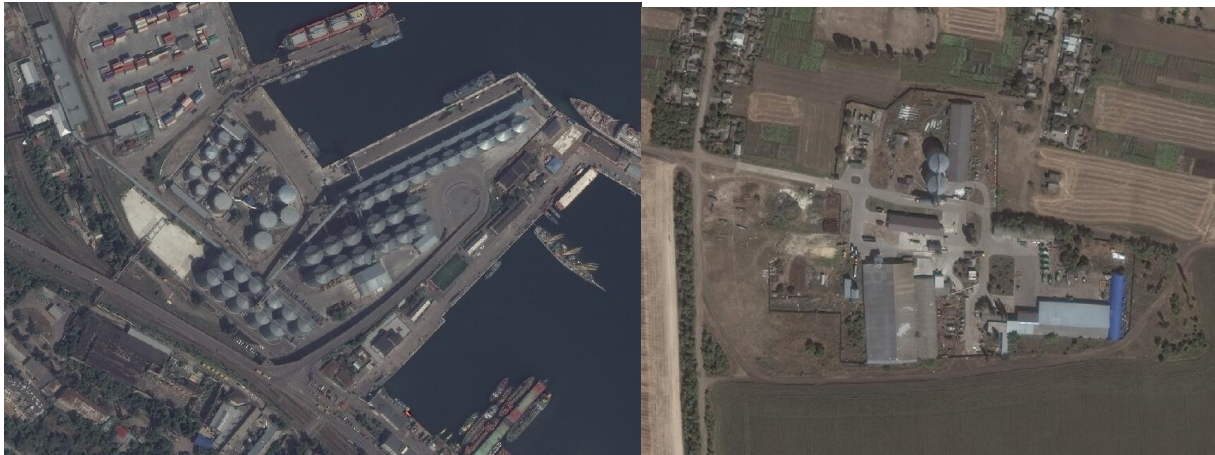
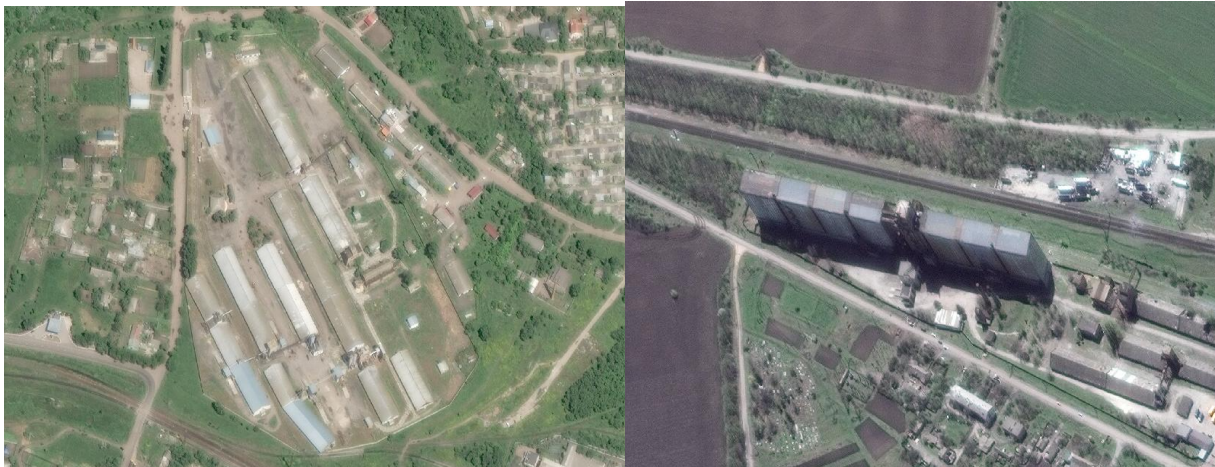
Figure 1. Examples of crop facility morphology.

1.A. 241k tonne capacity shipping facility ©2022 Maxar Technologies 1.B. 9.5k tonne capacity rural crop facility ©2020 Maxar Technologies

1.C. 50k tonne capacity shipping facility ©2021 Maxar Technologies 1.D. 150k tonne capacity rural crop facility ©2022 Maxar Technologies

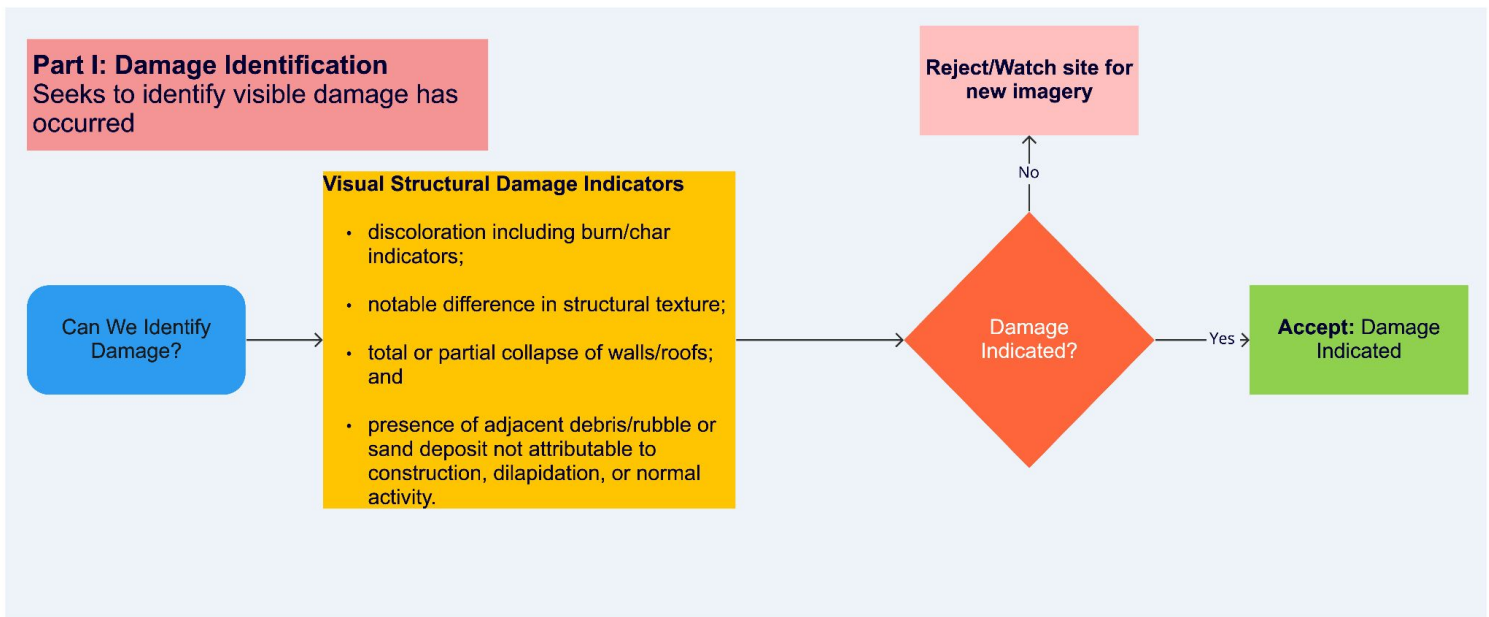
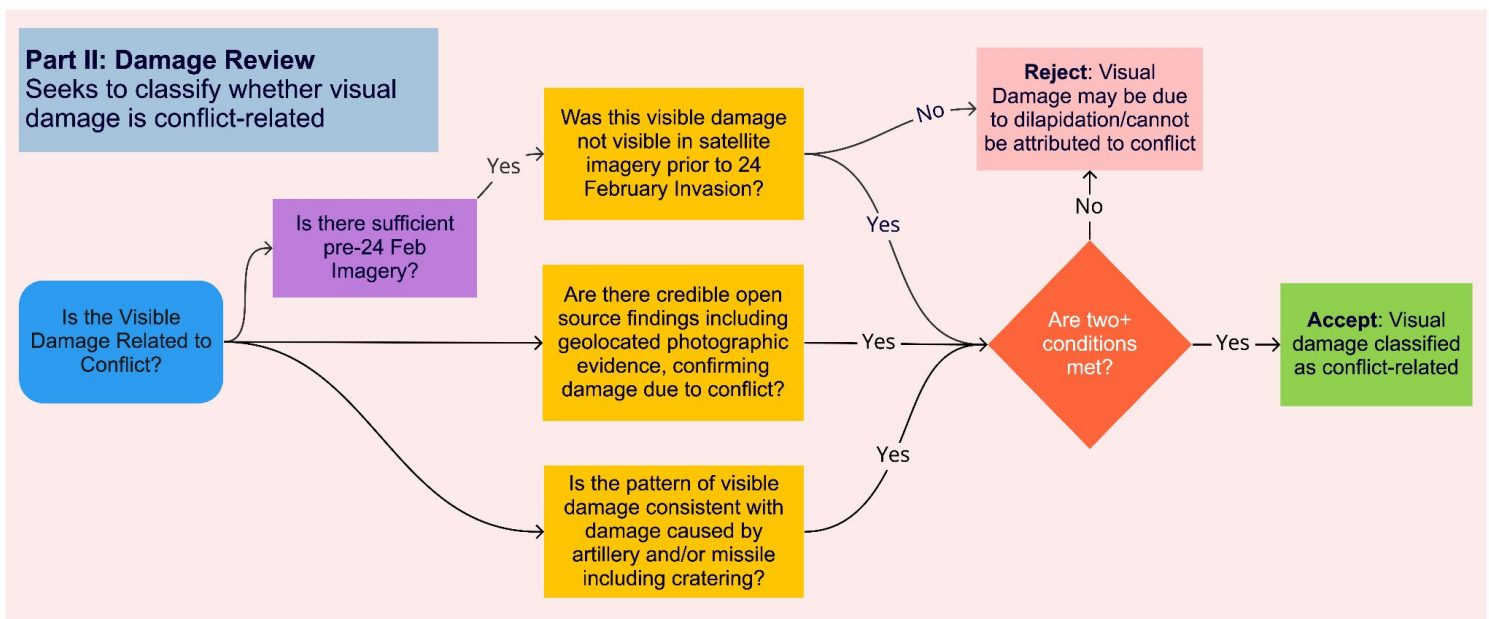
Figure 7: Damage Identification Process³⁴

³⁴ Pattern of visible damage consistent with damage caused by artillery, aerially dropped munitions, and/or missiles: Visible locus of apparent direct impact (on a roof or on the ground) with indications of damage spreading beyond that single point – which may include, but is not limited to, gradually smaller markings and/or perforations in roofing, or a perimeter of rubble – is considered highly consistent with damage caused by artillery and/or missile fire. The visual profile of unforced structural dilapidation is not consistent with this pattern of damage. See Appendix II for more information on damage indicators.

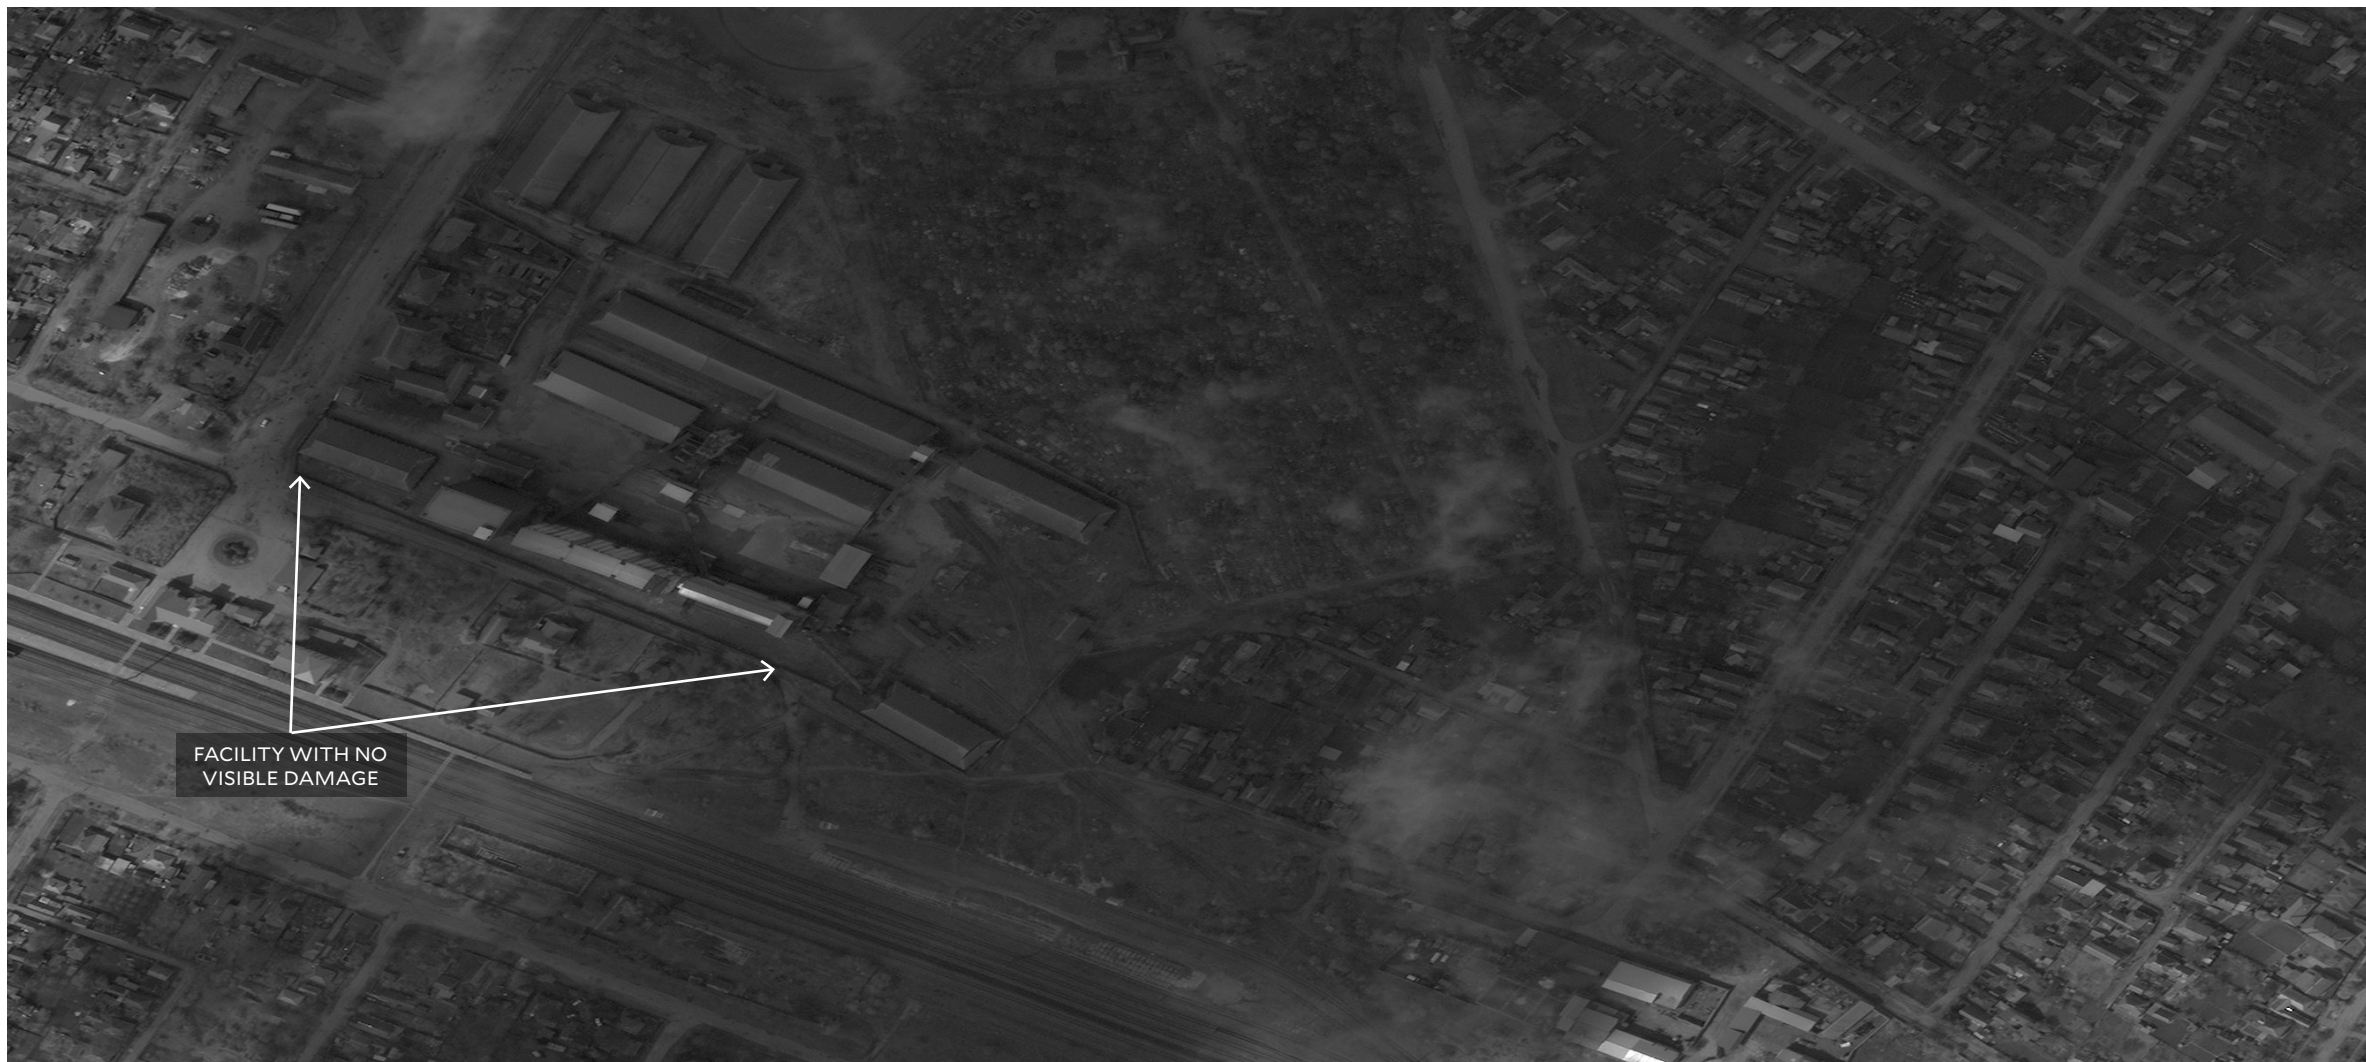
FACILITY WITH NO
VISIBLE DAMAGE

Date: 2022.04.22
Source: WV01
Ground Sampling Distance: 50 cm
Off-Nadir: 19.7596°

There is no apparent damage to the facility
or the surrounding area.

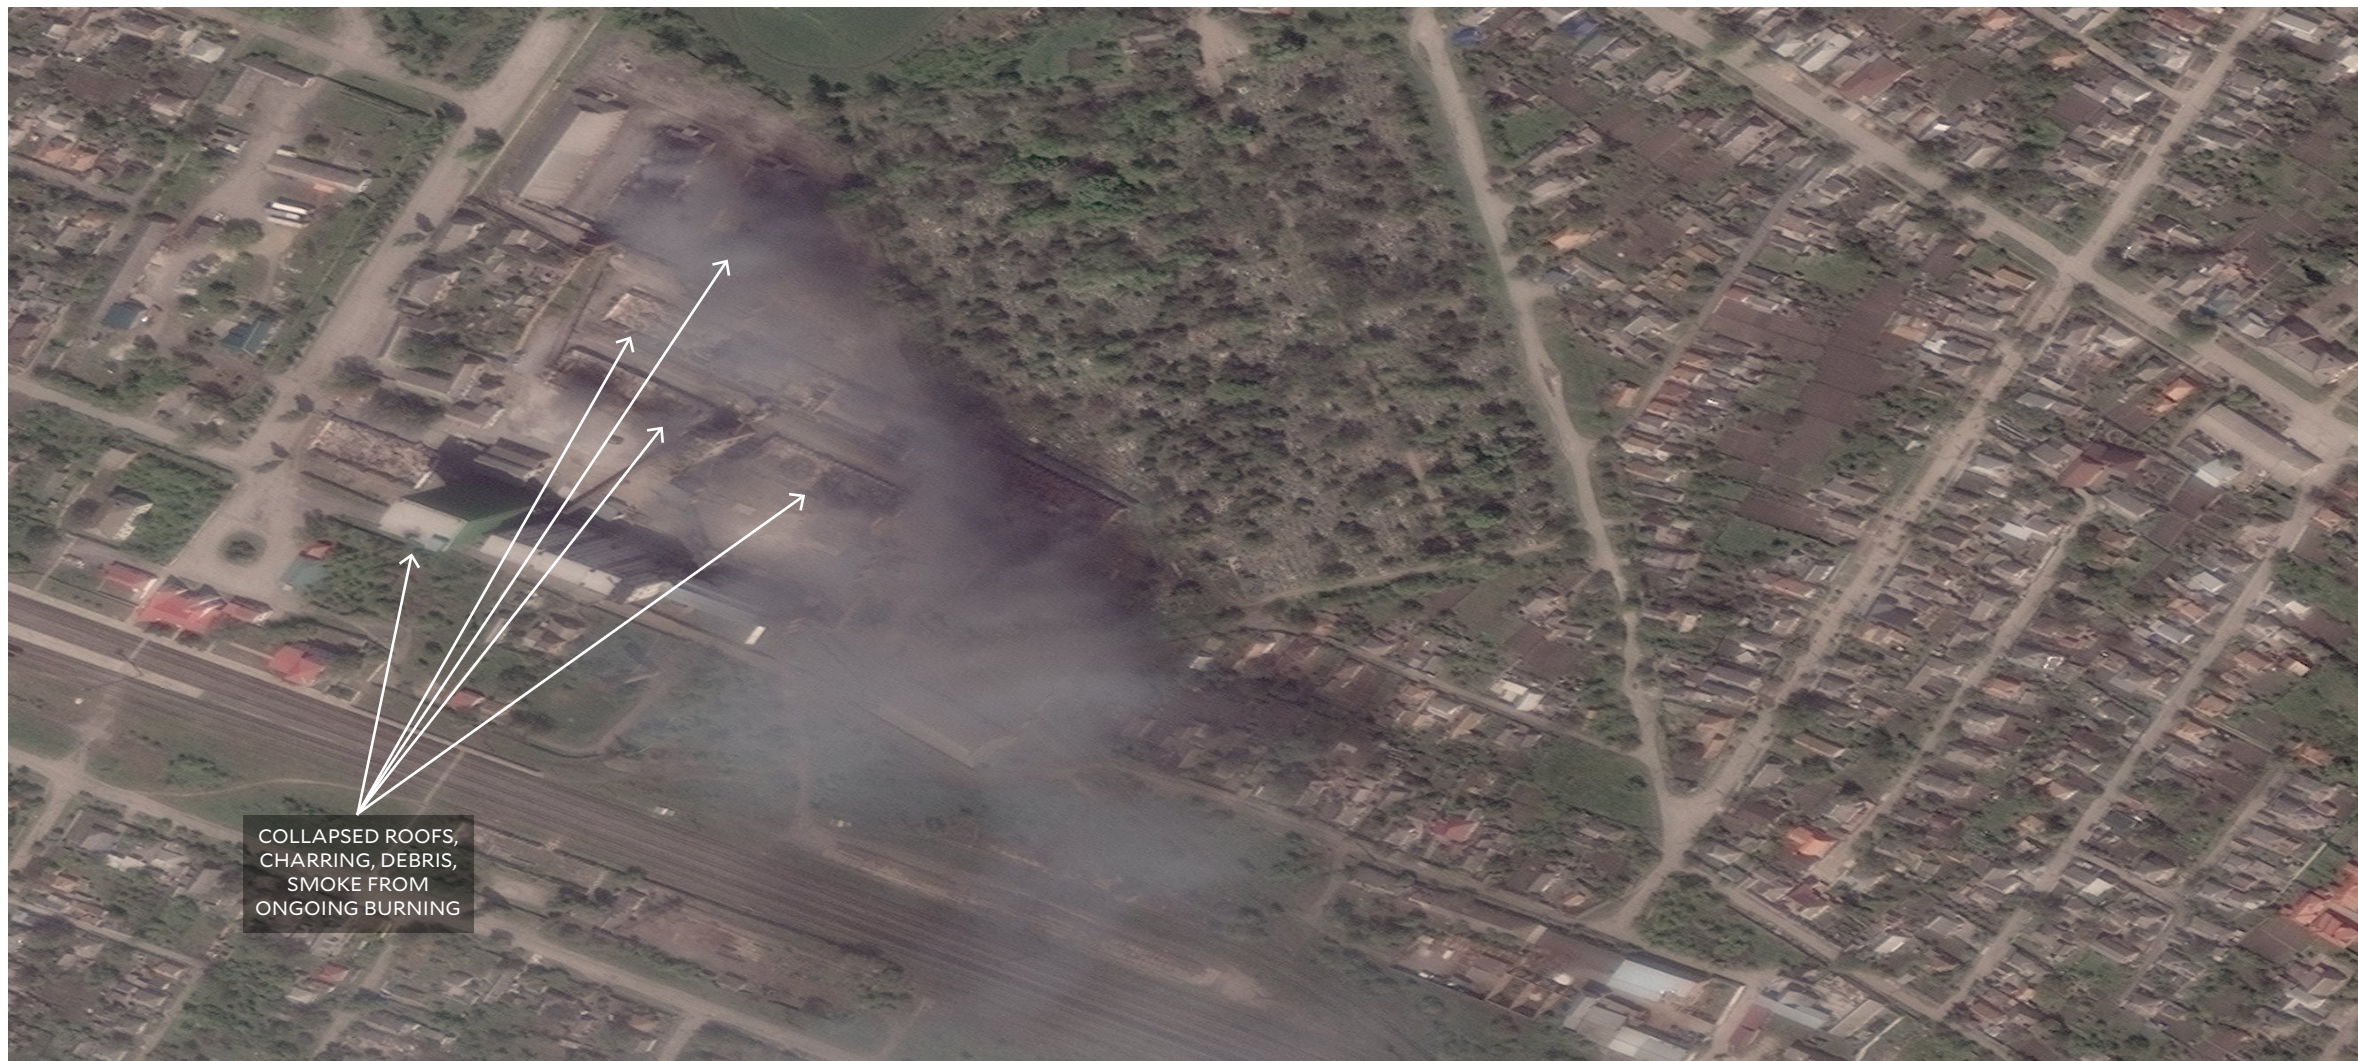
**CROP STORAGE: ORIKHIV VSP
OPTIMUSAGRO TRADE
ZAPORIZHZHYA OBLAST**

Damage appears consistent with effects of heavy artillery and/or missile fire: several facility roofs appear to have collapsed and there appears to be severe charring and substantial debris.

Substantial smoke visible emanating from the facility. The smoke obscures a significant portion of the site, including areas that appear to have sustained the greatest damage.

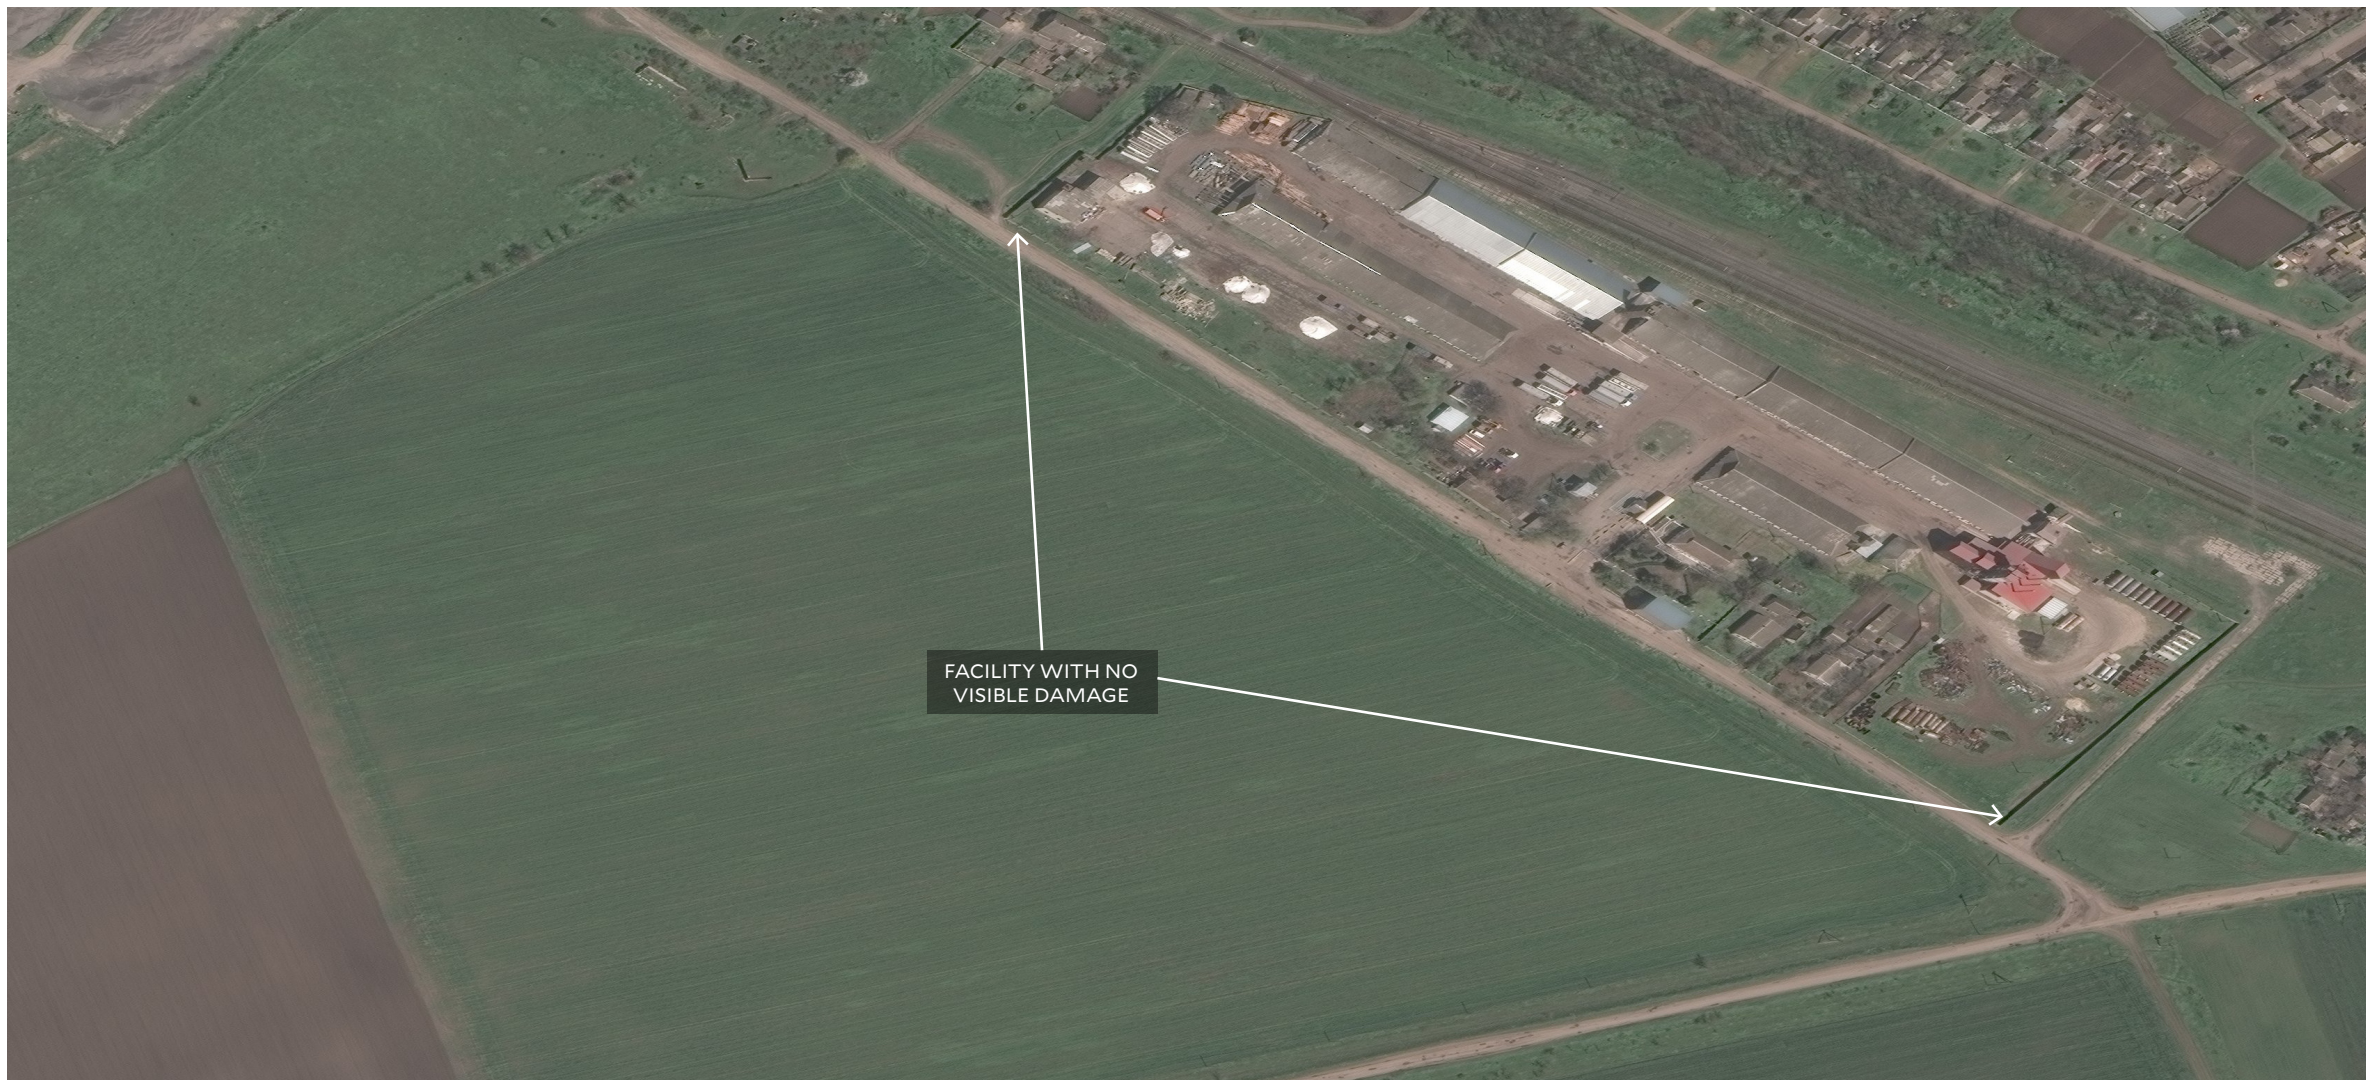
**ELEVATOR: GLOBAL GRAIN
(KOPAN HPP)
KHERSON OBLAST**

Date: 2021.04.24
Source: WV03
Ground Sampling Distance: 38 cm
Off-Nadir: 26.2932°

There is no apparent damage to the facility or the surrounding area.

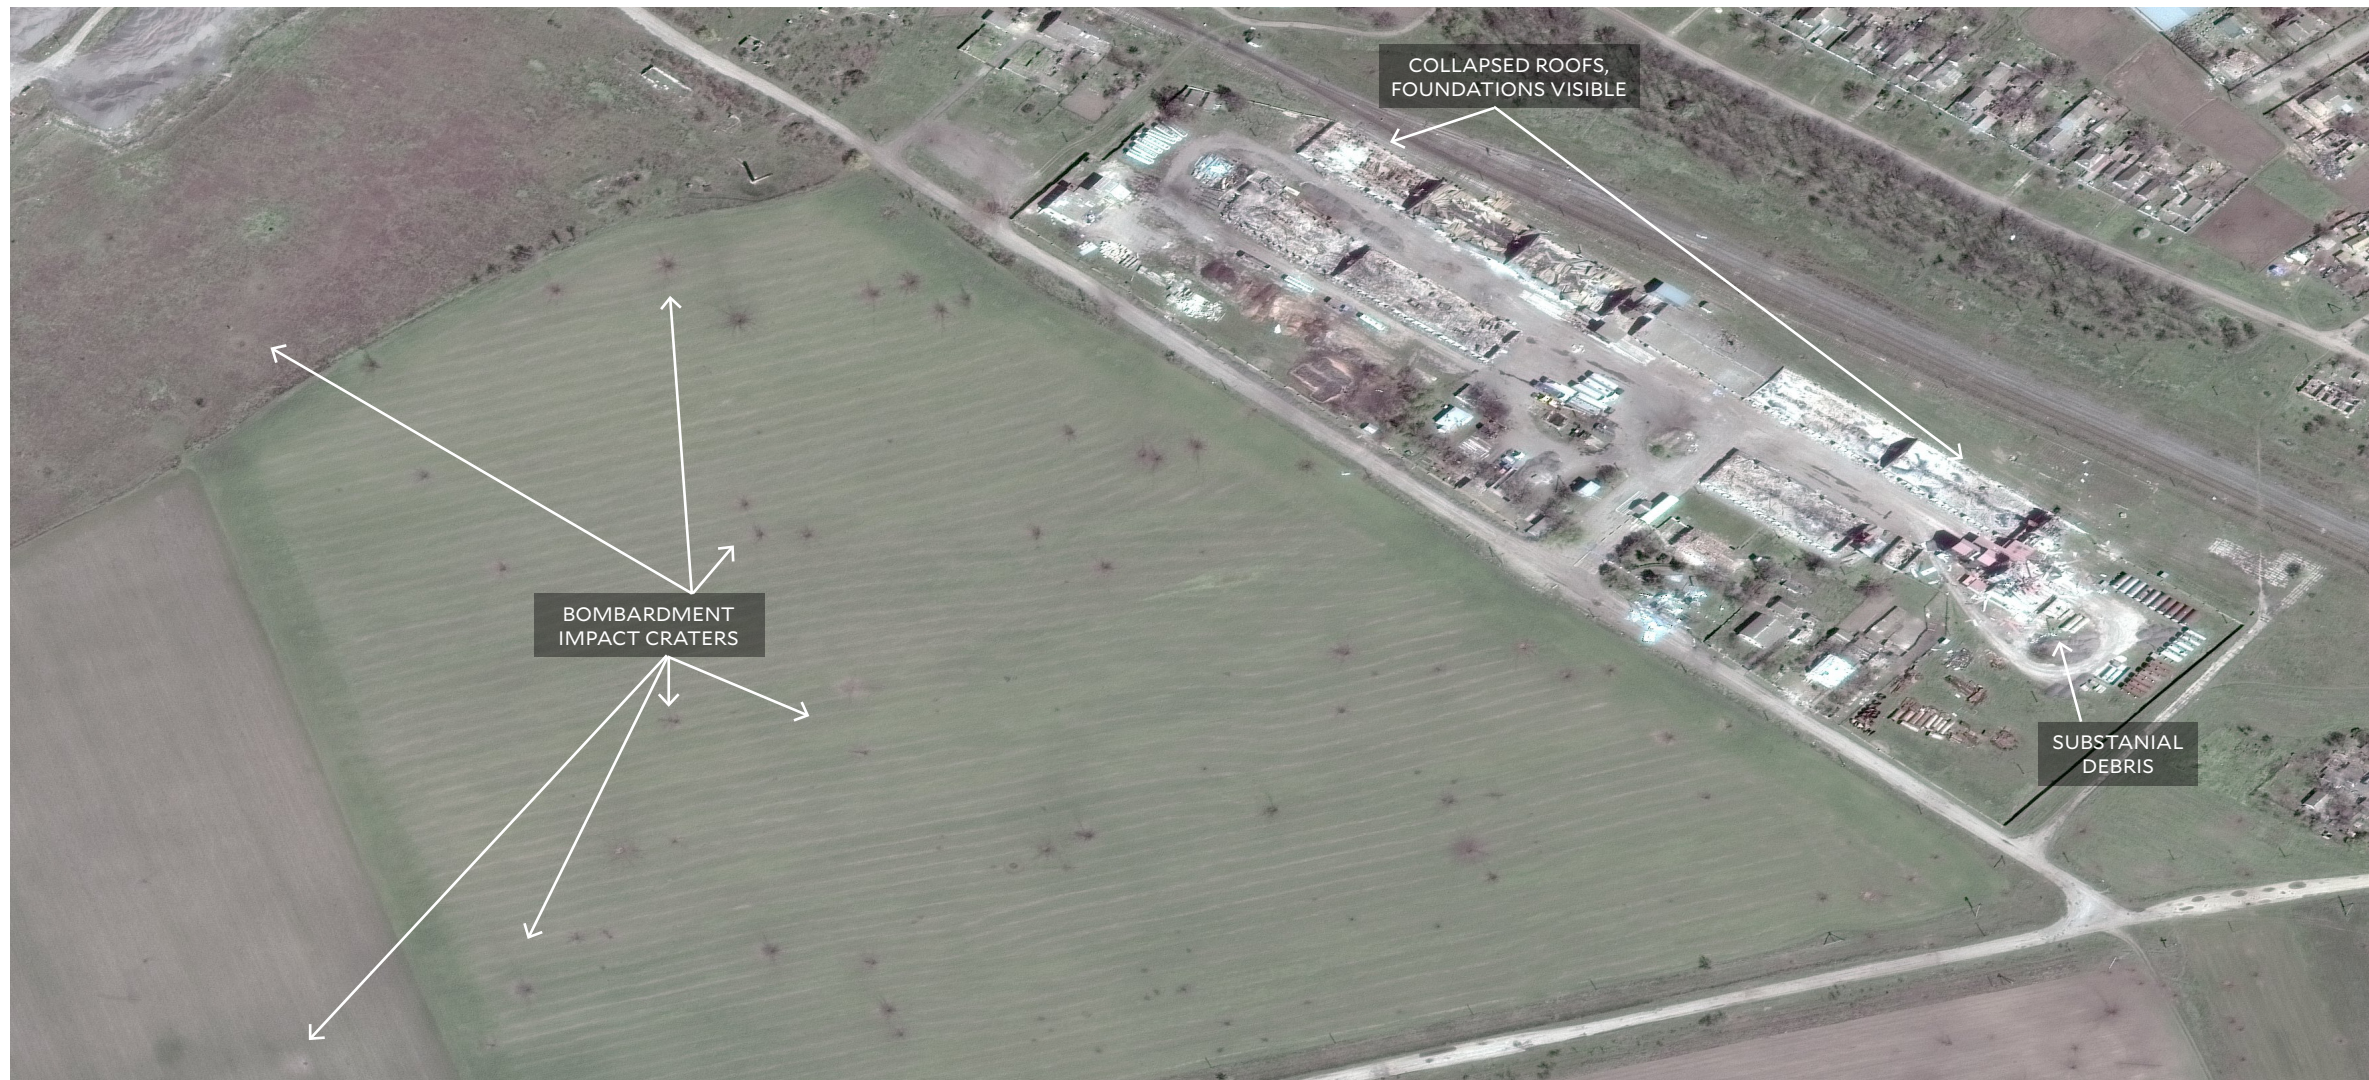
**ELEVATOR: GLOBAL GRAIN
(KOPAN HPP)
KHERSON OBLAST**

Date: 2022.04.26
Source: WV03
Ground Sampling Distance: 36 cm
Off-Nadir: 24.7453°

Several buildings have sustained total or near-total damage within the facility. Impact craters appear to be visible in the field southwest of the facility site.

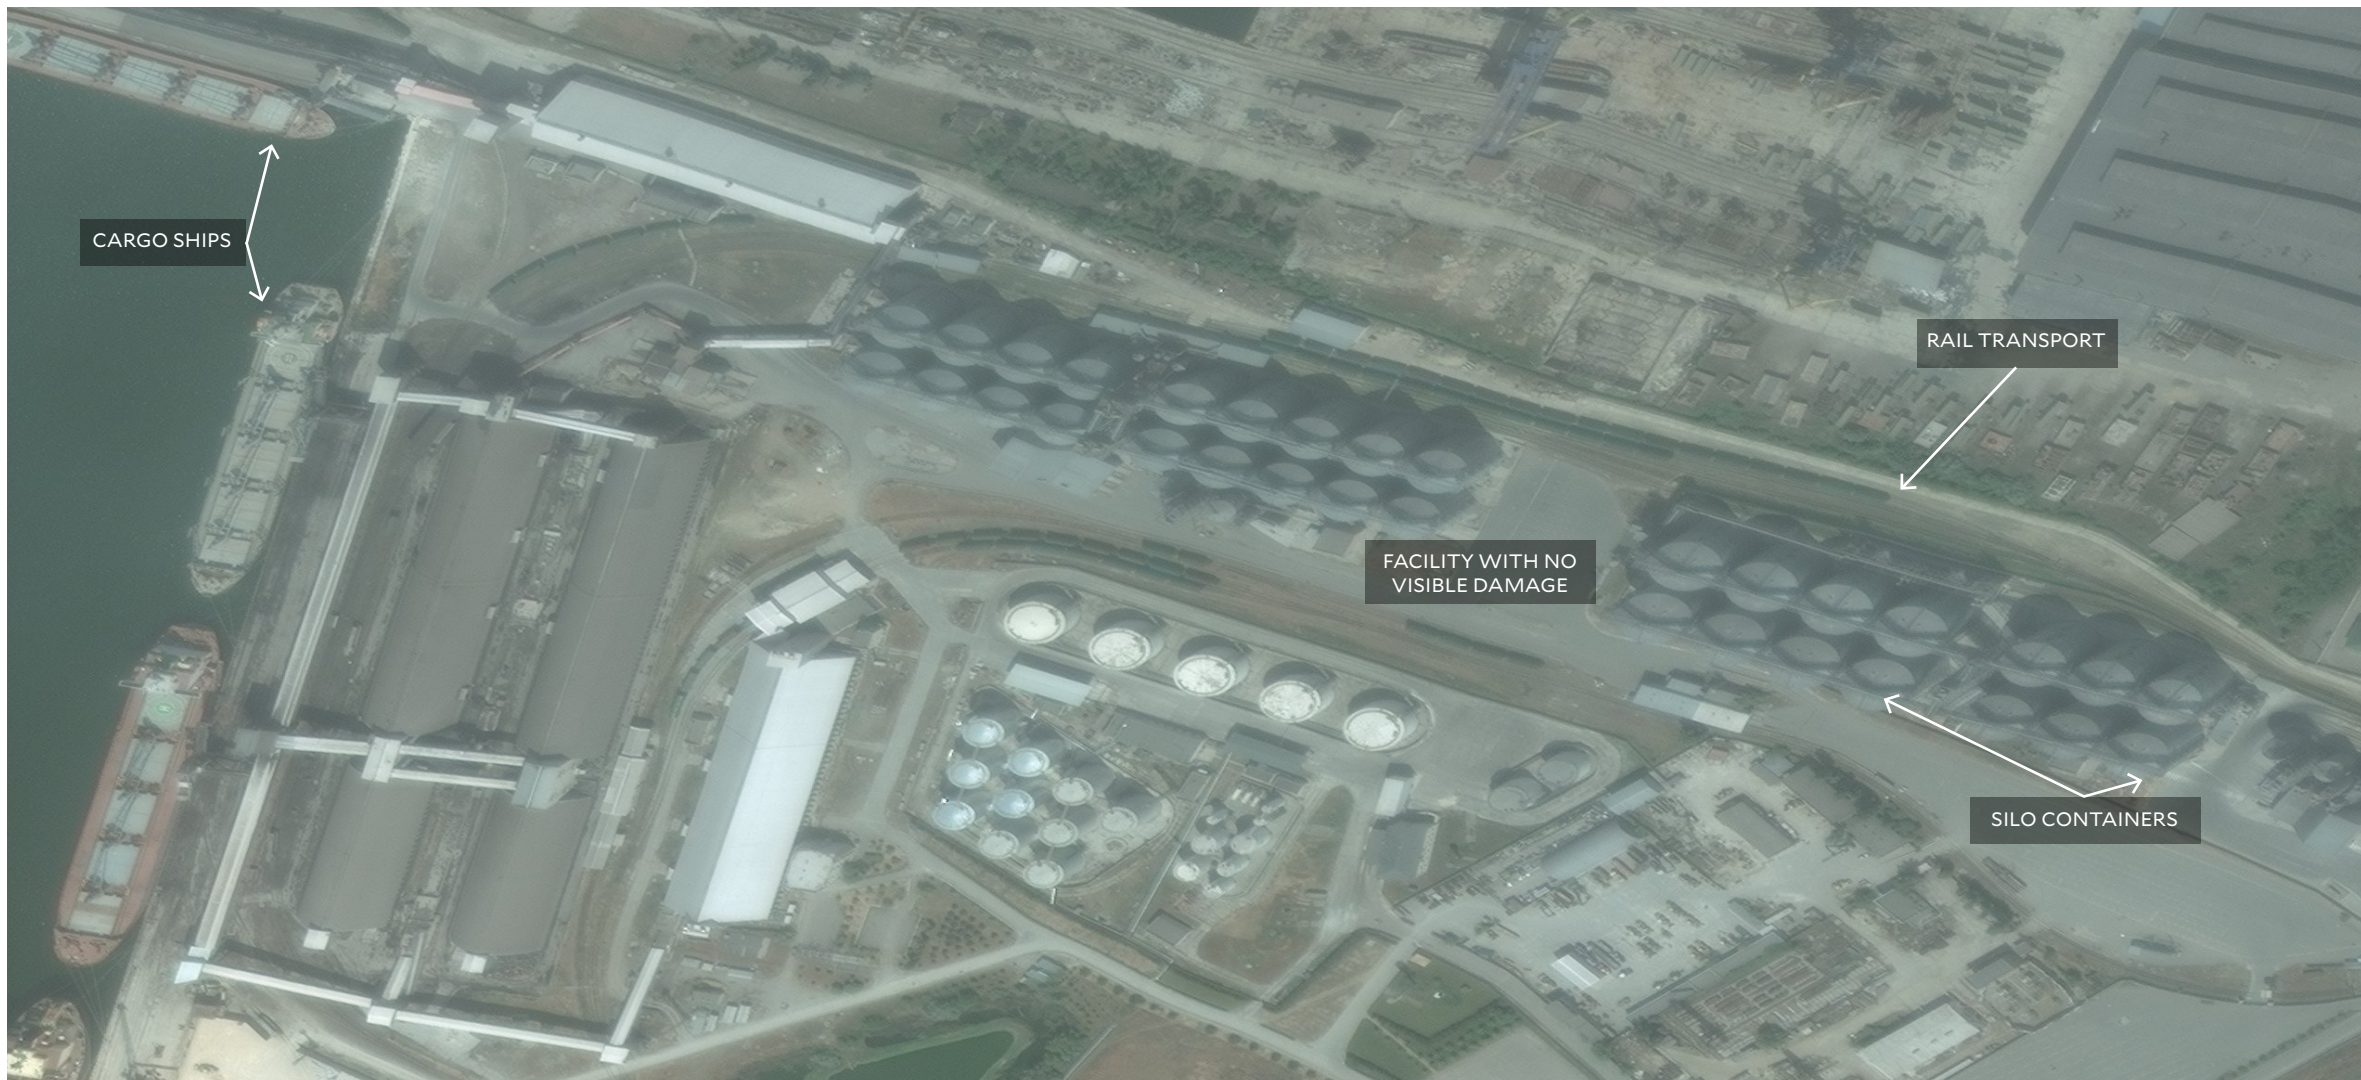
**SHIPPING COMPLEX:
NIKA-TERRA GRAIN TERMINAL
MYKOLAYIV OBLAST**

Date: 2022.05.21
Source: WV02
Ground Sampling Distance: 50 cm
Off-Nadir: 27.320982°

There is no apparent damage to the facility or the surrounding area.

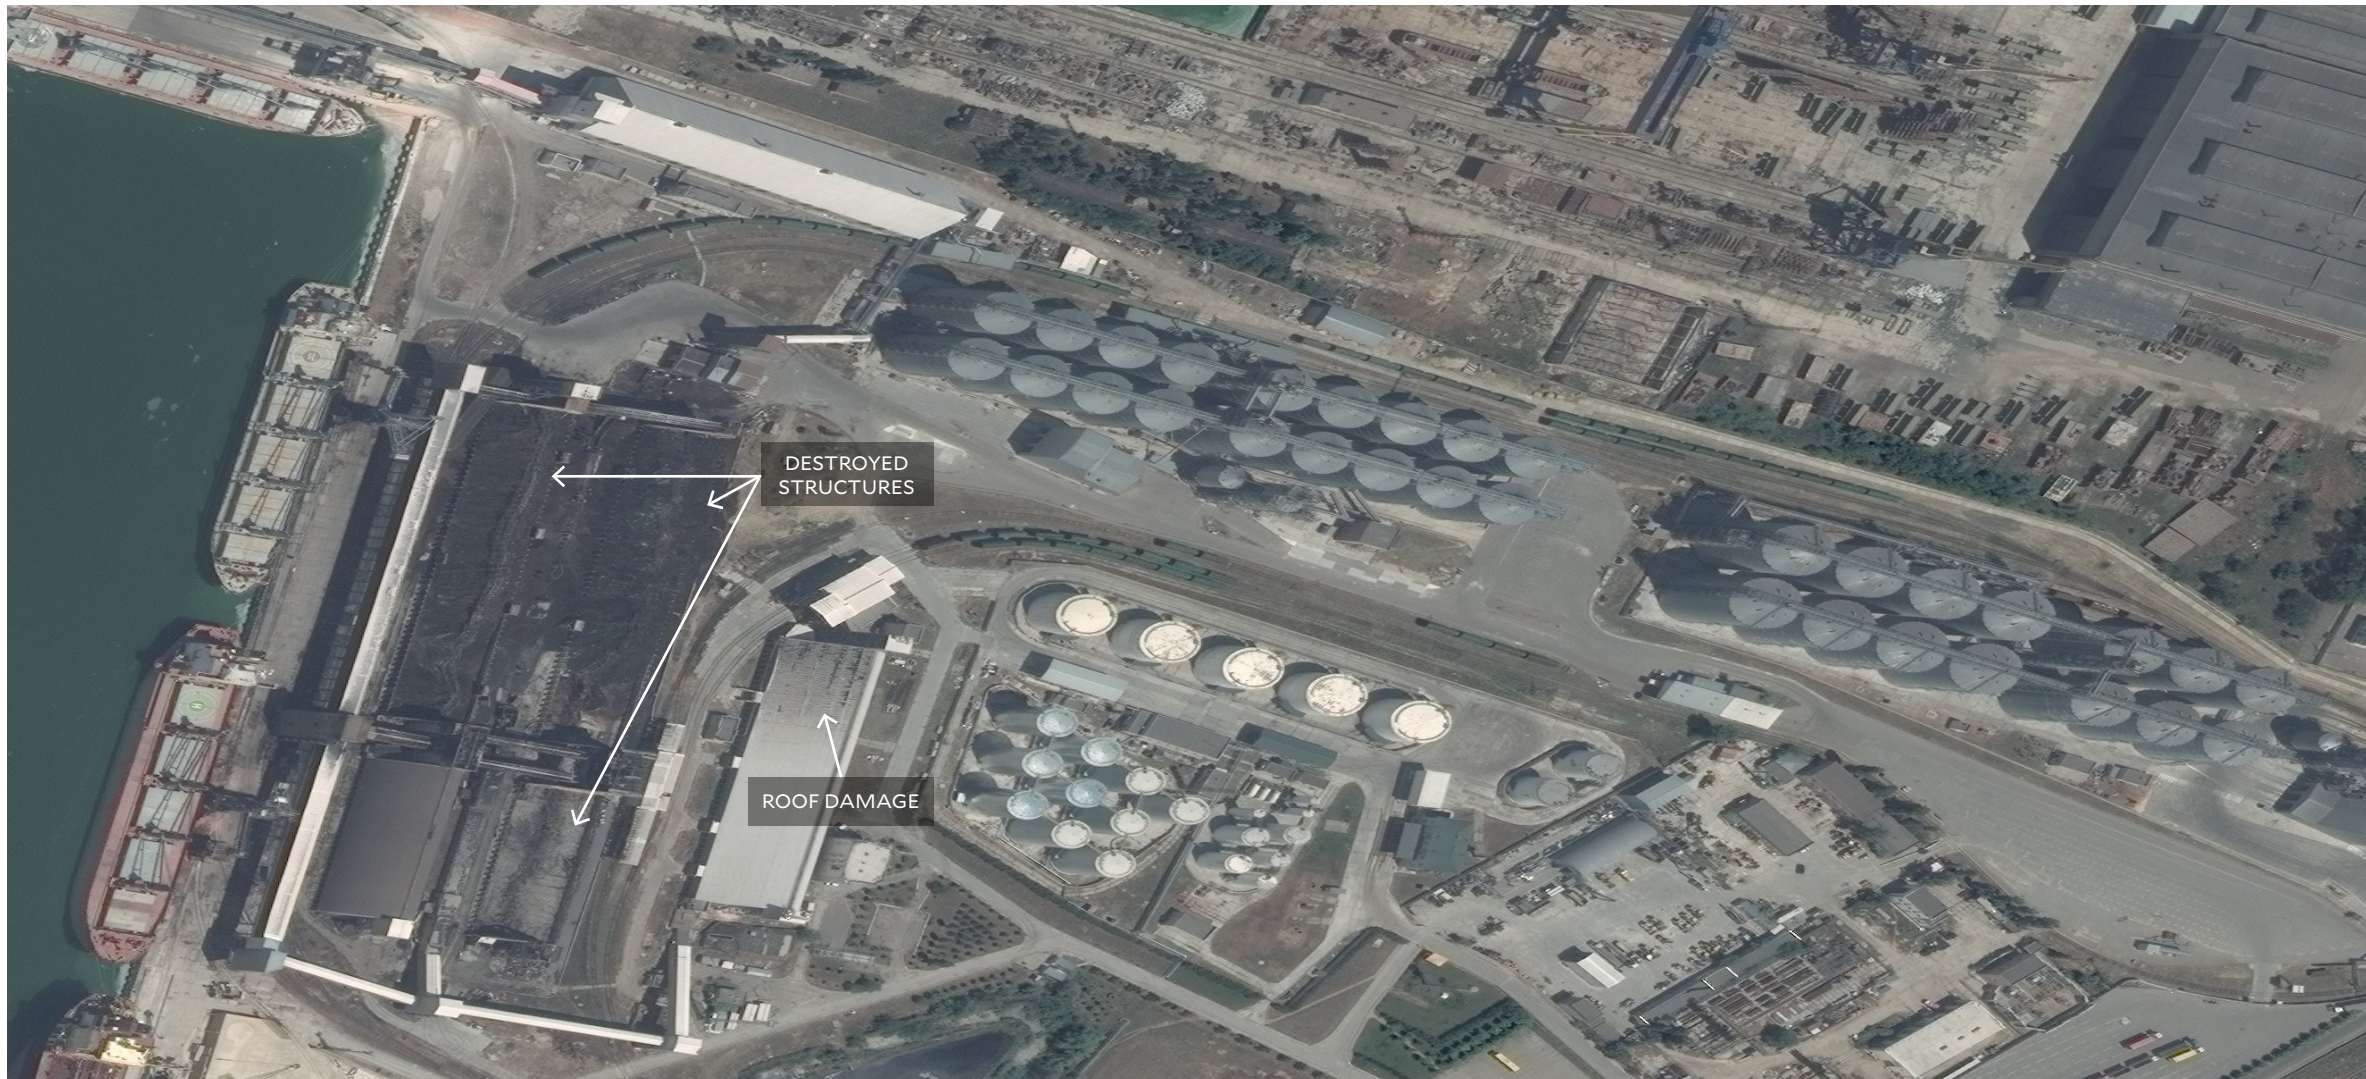
**SHIPPING COMPLEX:
NIKA-TERRA GRAIN TERMINAL
MYKOLAYIV OBLAST**

Date: 2022.07.05
Source: WV03
Ground Sampling Distance: 48 cm
Off-Nadir: 38.344563°

Three of the four facility buildings located by the waterfront appear to have sustained total damage. A building east of these now-roofless structures appears to have sustained damage to its north-end roof.

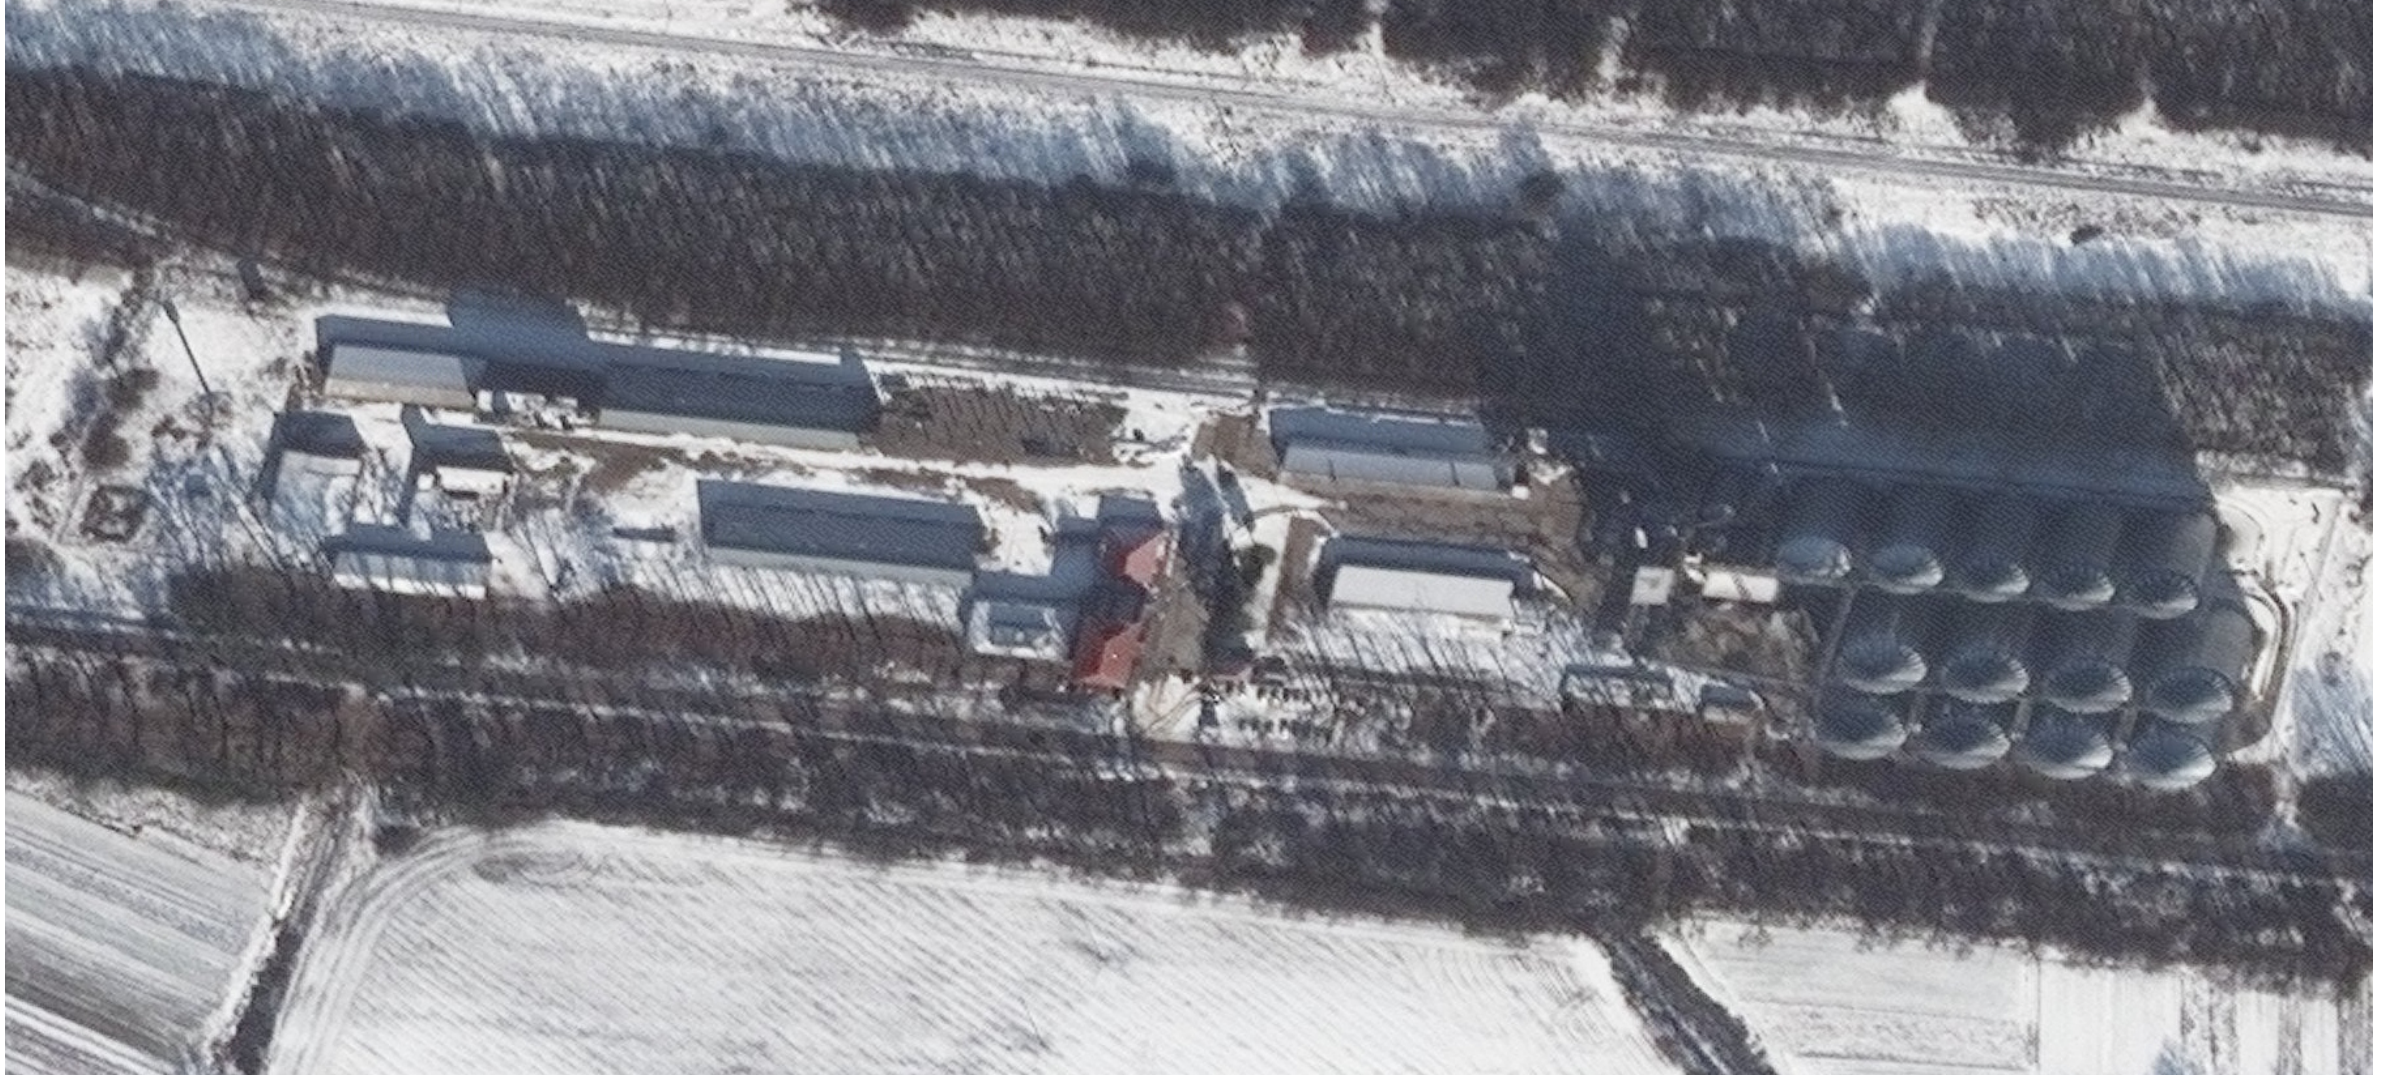
**SILO COMPLEX: PORTTRANSBUD
(OVRUCH BRANCH RISE)
ZHYTOMYR OBLAST**

Date: 2022.02.14
Source: WV02
Ground Sampling Distance: 50 cm
Off-Nadir: 37.1811°

There is no apparent damage to the facility
or the surrounding area.
