Ukraine's Crop Storage Infrastructure: Post-Invasion Impact Assessment

15 September 2022

Yale SCHOOL OF PUBLIC HEALTH
Humanitarian Research Lab

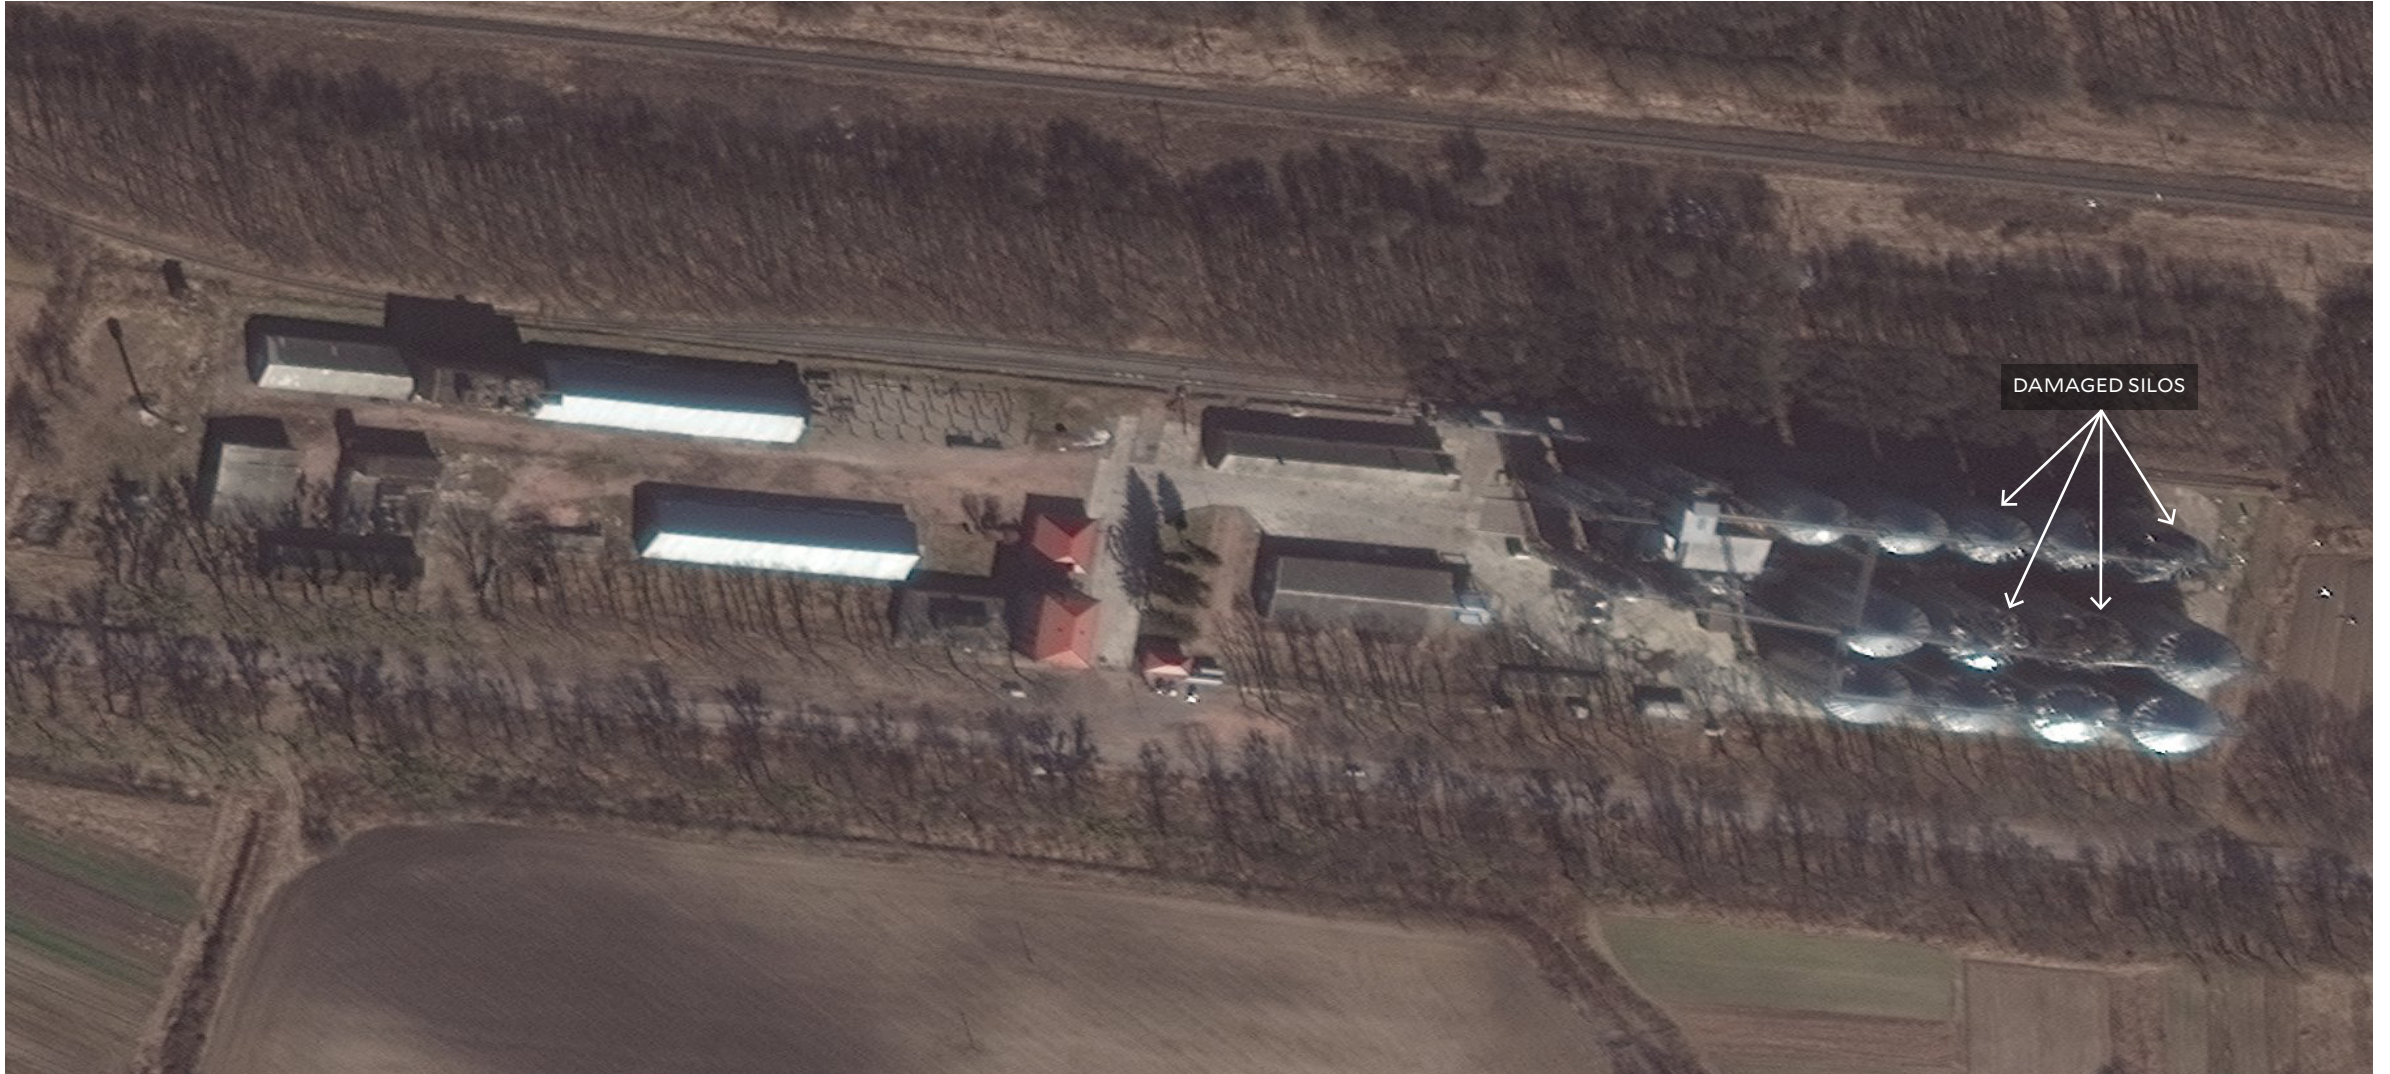
**SILO COMPLEX: PORTTRANSBUD
(OVRUCH BRANCH RISE)
ZHYTOMYR OBLAST**

Date: 2022.02.27
Source: WV02
Ground Sampling Distance: 50 cm
Off-Nadir: 28.7099°

Dark markings consistent with charring or absent roofing are present on at least six of the facility's silo tops. The greatest apparent damage is observed to the silo in the center row, second from the right (east).

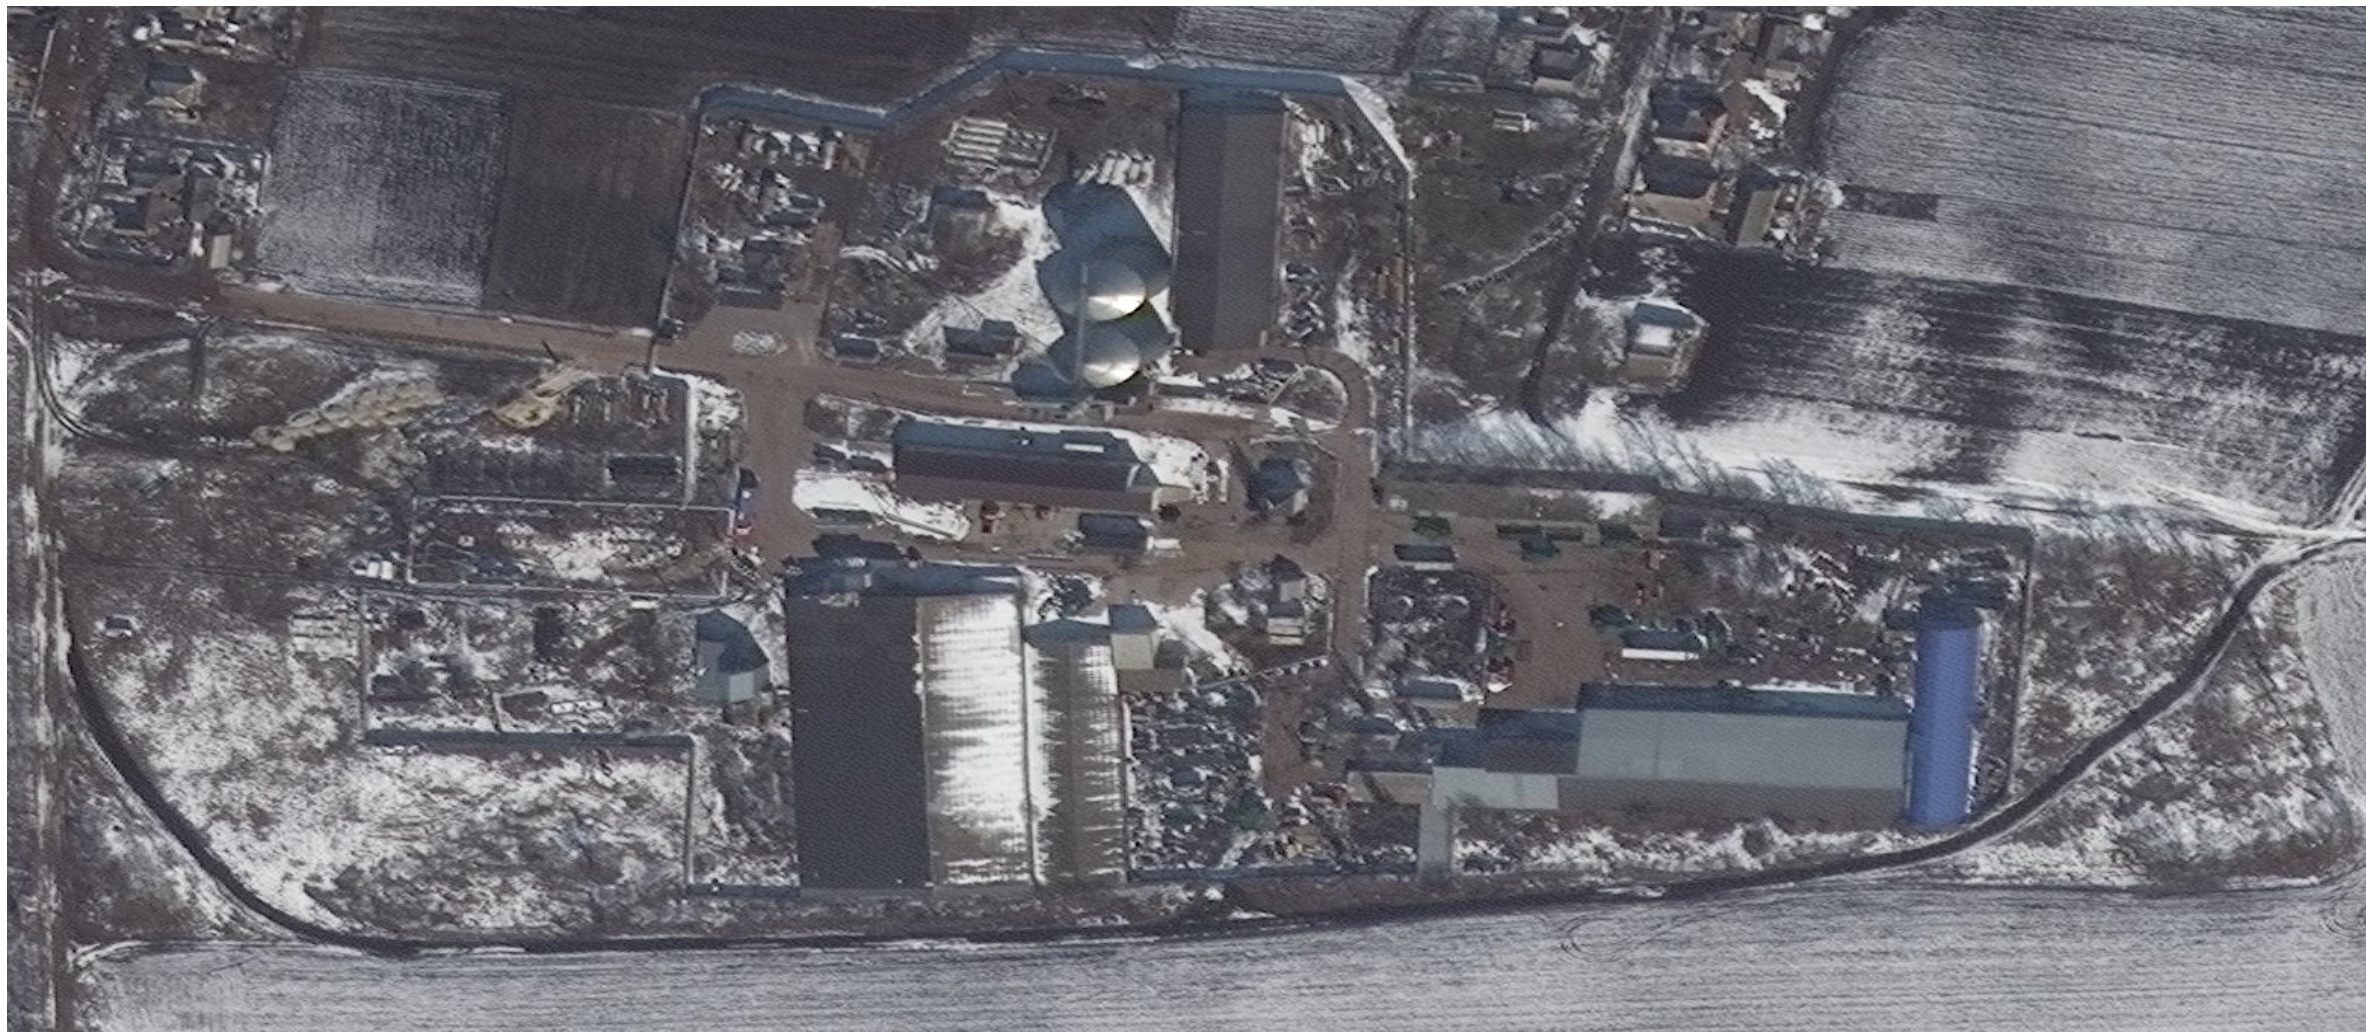
**SMALL-SCALE CROP FACILITY:
DAFETY SFH
DONETSK OBLAST**

Date: 2022.03.12
Source: WV02
Ground Sampling Distance: 50 cm
Off-Nadir: 26.9844°

There is no apparent damage to the facility
or the surrounding area.

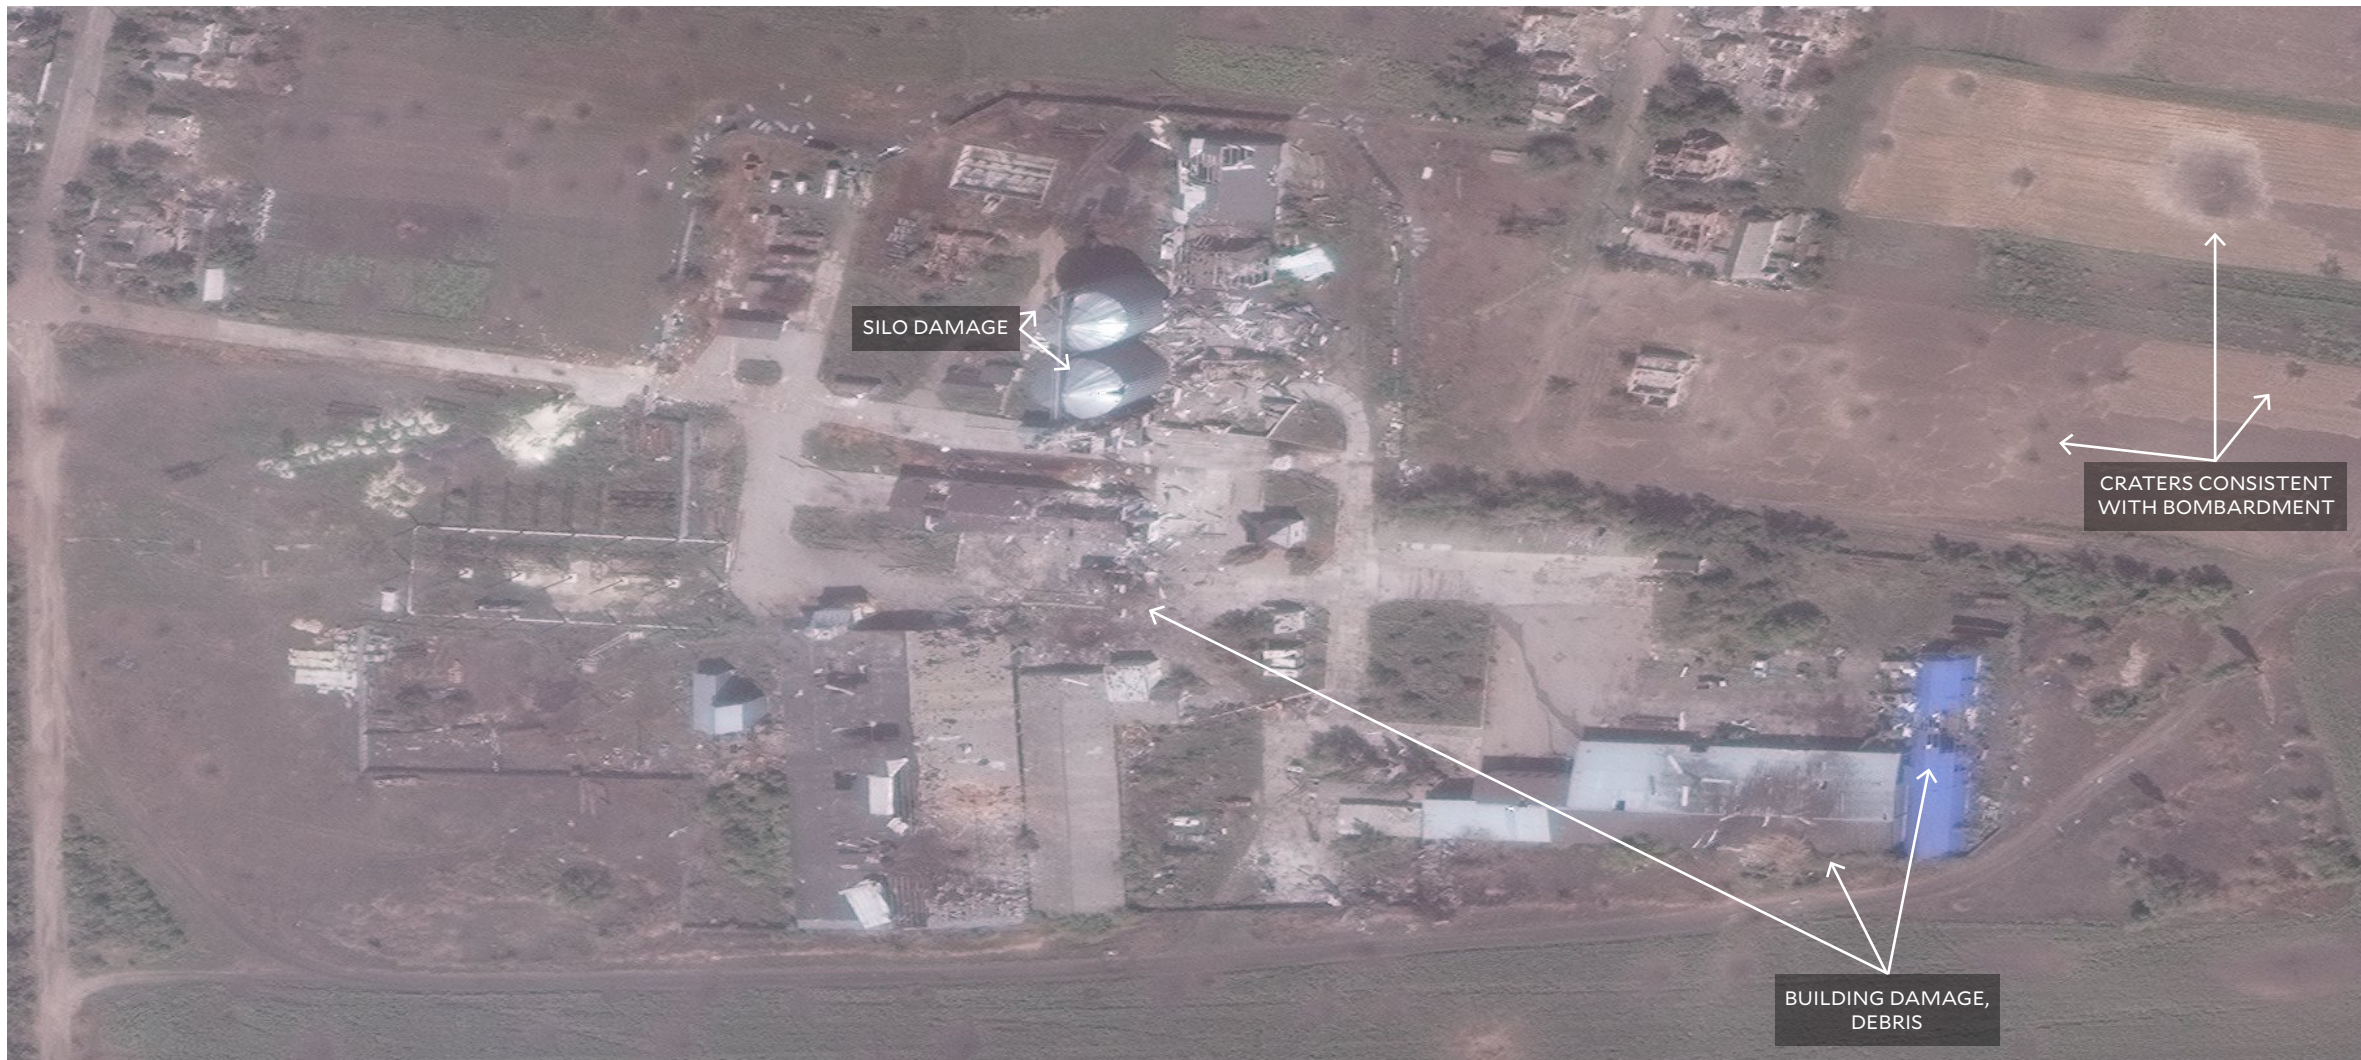
**SMALL-SCALE CROP FACILITY:
DAFETY SFH
DONETSK OBLAST**

Date: 2022.08.01
Source: WV03
Ground Sampling Distance: 43 cm
Off-Nadir: 33.6127°

Damage to the facility and surrounding (ostensibly residential) infrastructure appears consistent with effects of artillery and/or missile fire. There is damage observed to the facility's silo tops and

several other buildings have also sustained damage. Impact craters are visible in fields surrounding the facility.
