# **Confirmation: Destruction of Aircraft at RSF-Held Nyala Airport**

8 May 2025

# Nyala Airport

## THERMAL SCARRING AND DEBRIS OBSERVED BETWEEN 01-06 MAY 2025

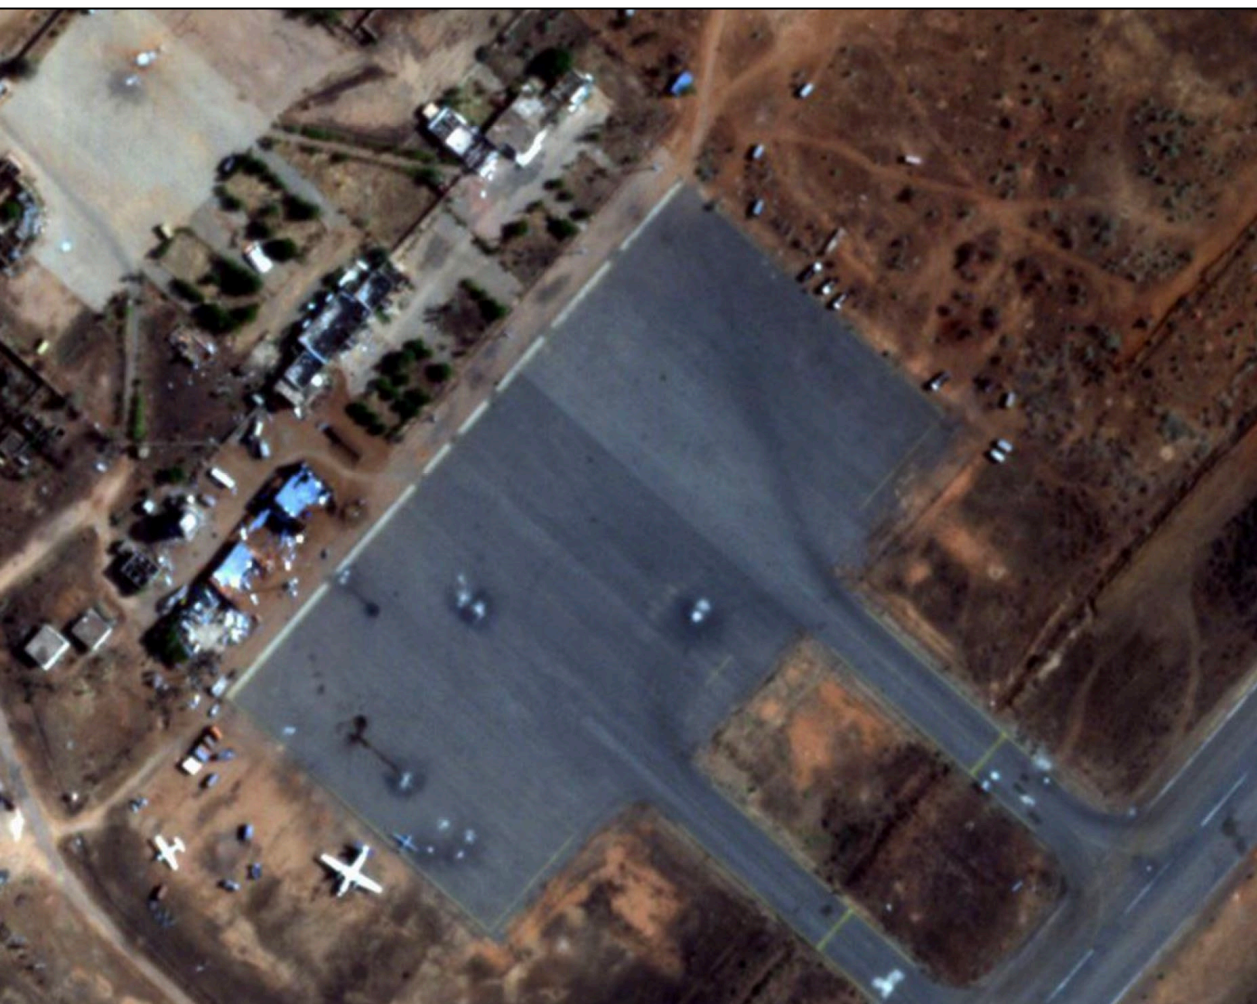
01 May 2025 © 2025 Planet PBC, USG-Plus

Analysis of satellite imagery collected between 01 and 06 May 2025 of Nyala Airport shows the new presence of a burn scar, measuring approximately 1 km<sup>2</sup> in area, on the main apron of the airstrip. Streaks leading from the burn scar to the northern edge of the apron show that likely debris, including a wing from an aircraft, has been pulled from the apparent wreckage.

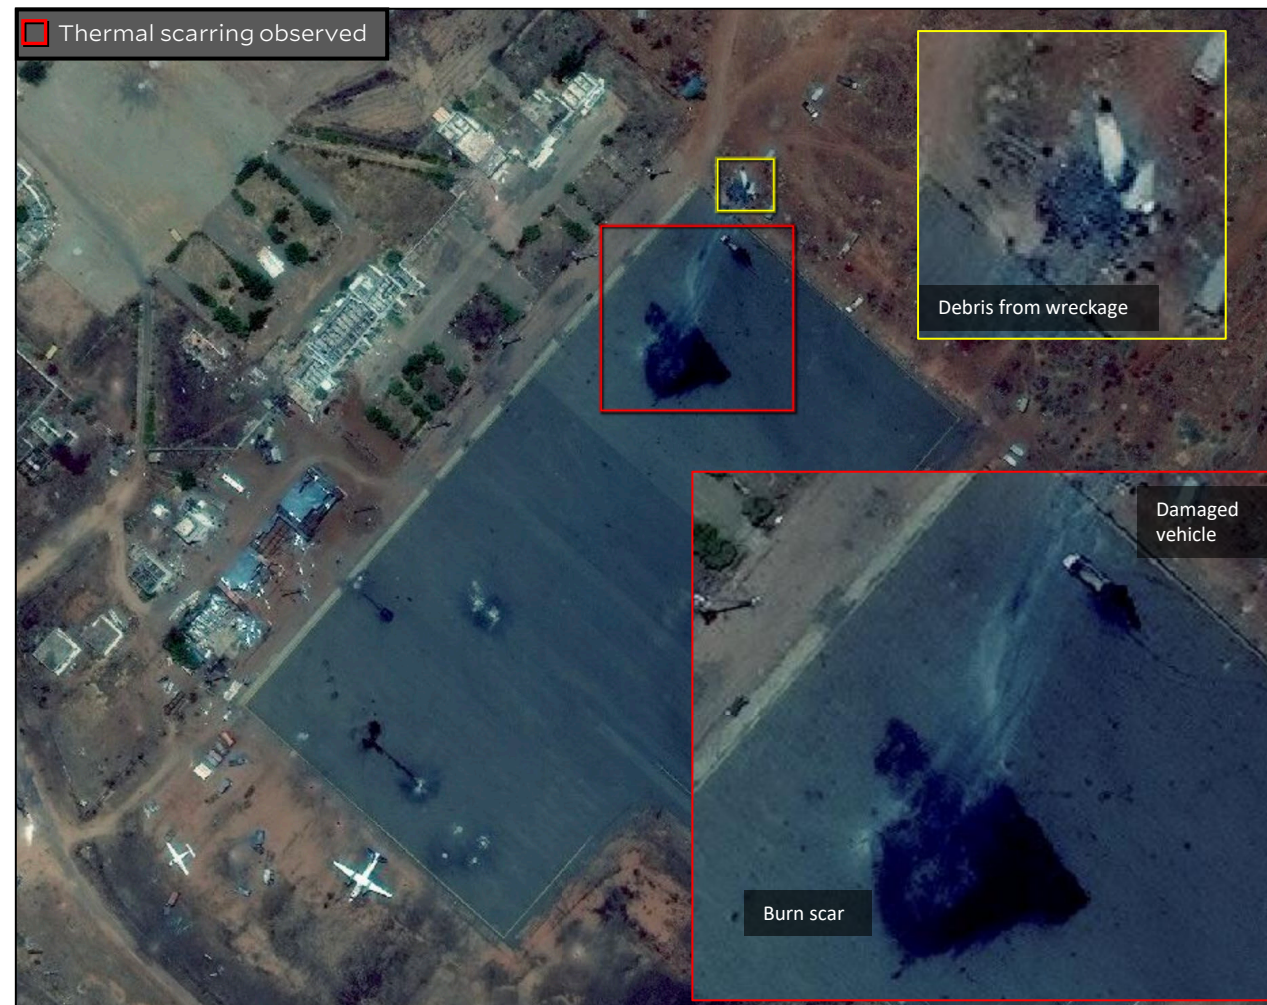
06 May 2025 © 2025 Maxar, USG-Plus

Additionally, an open-back cargo truck likely sustained damage as evident by thermal scarring visible at the rear of its chassis.

The thermal scarring is visible in analysis of low-resolution Sentinel-2 imagery collected on 05 May 2025, narrowing the timeframe of the event to between 01 and 05 May 2025.
