Advanced UAV Destroyed at RSF-Held Nyala Airport

27 June 2025

Yale SCHOOL OF PUBLIC HEALTH
Humanitarian Research Lab

CONFLICT-RELATED DAMAGE OBSERVED BETWEEN 11-21 JUNE 2025

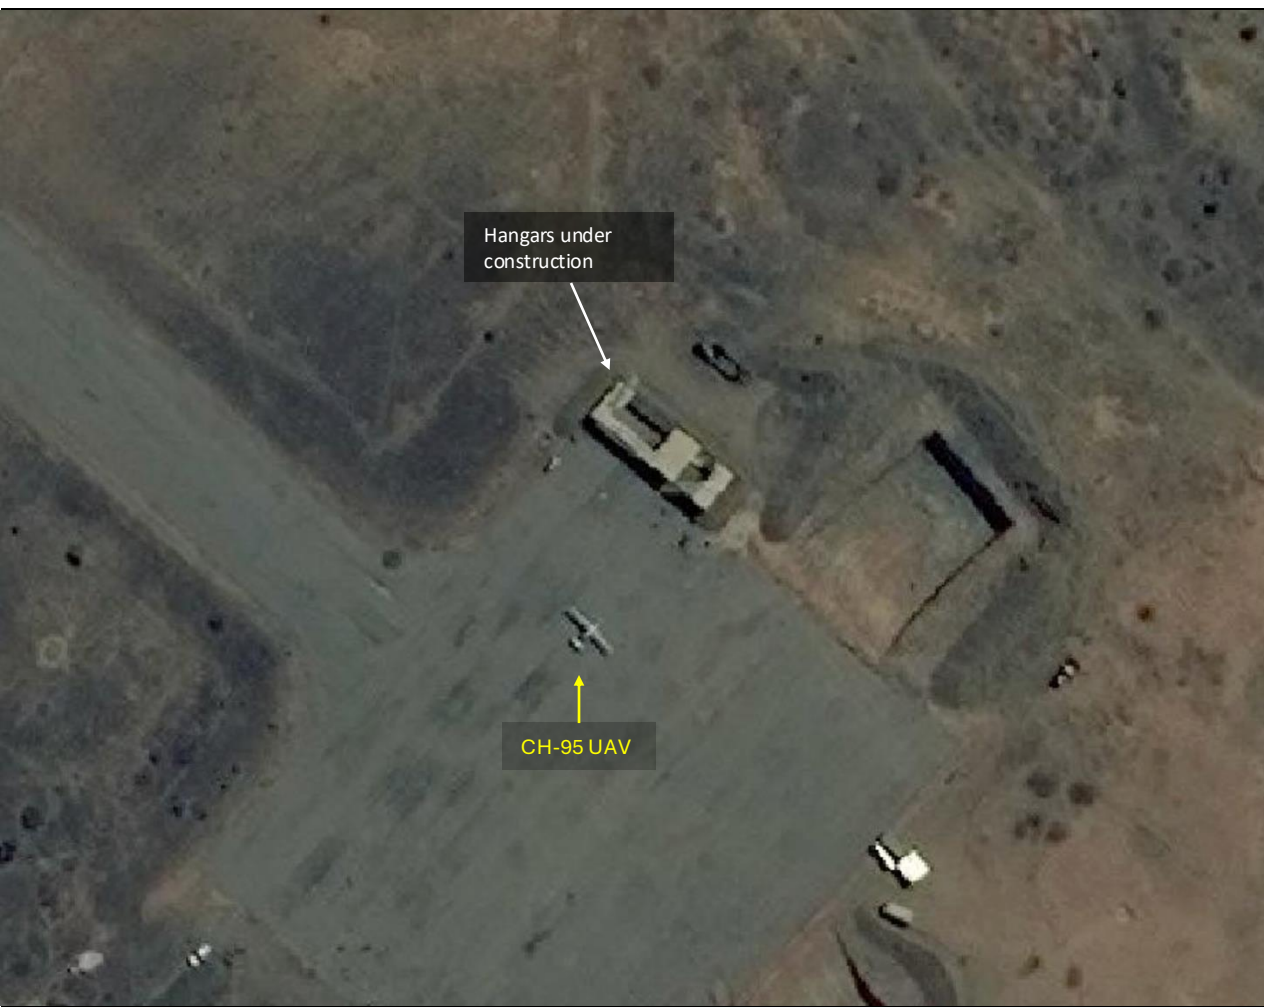
Analysis of satellite imagery collected between 11 and 21 June 2025 over the Nyala airport shows damage from a likely munition impact to hangars under construction on the northern end of the airstrip

At least one likely advanced unmanned aerial vehicle (UAV) was destroyed and a structure under construction at Rapid Support Forces (RSF)-held Nyala Airport was damaged between 11-16 June 2025. The Yale School of Public Health's Humanitarian Research Lab (HRL) identifies two munition impacts in close proximity and debris visible in satellite imagery from 21 June 2025. The debris near one of the munition impacts is consistent in appearance and dimension with the wing of the UAVs first visible at Nyala airport on 9 December 2025. These UAVs are believed to be consistent with either CH-95s or FH-95s.¹ Yale HRL has identified as many as 6 advanced unmanned aerial vehicles (UAVs) at Nyala Airport in satellite imagery since 24 April 2025.² Damage likely occurred between 11 and 16 June 2025; damage and debris consistent with the wing of a UAV was not clearly visible in very high resolution satellite imagery until 21 June 2025.

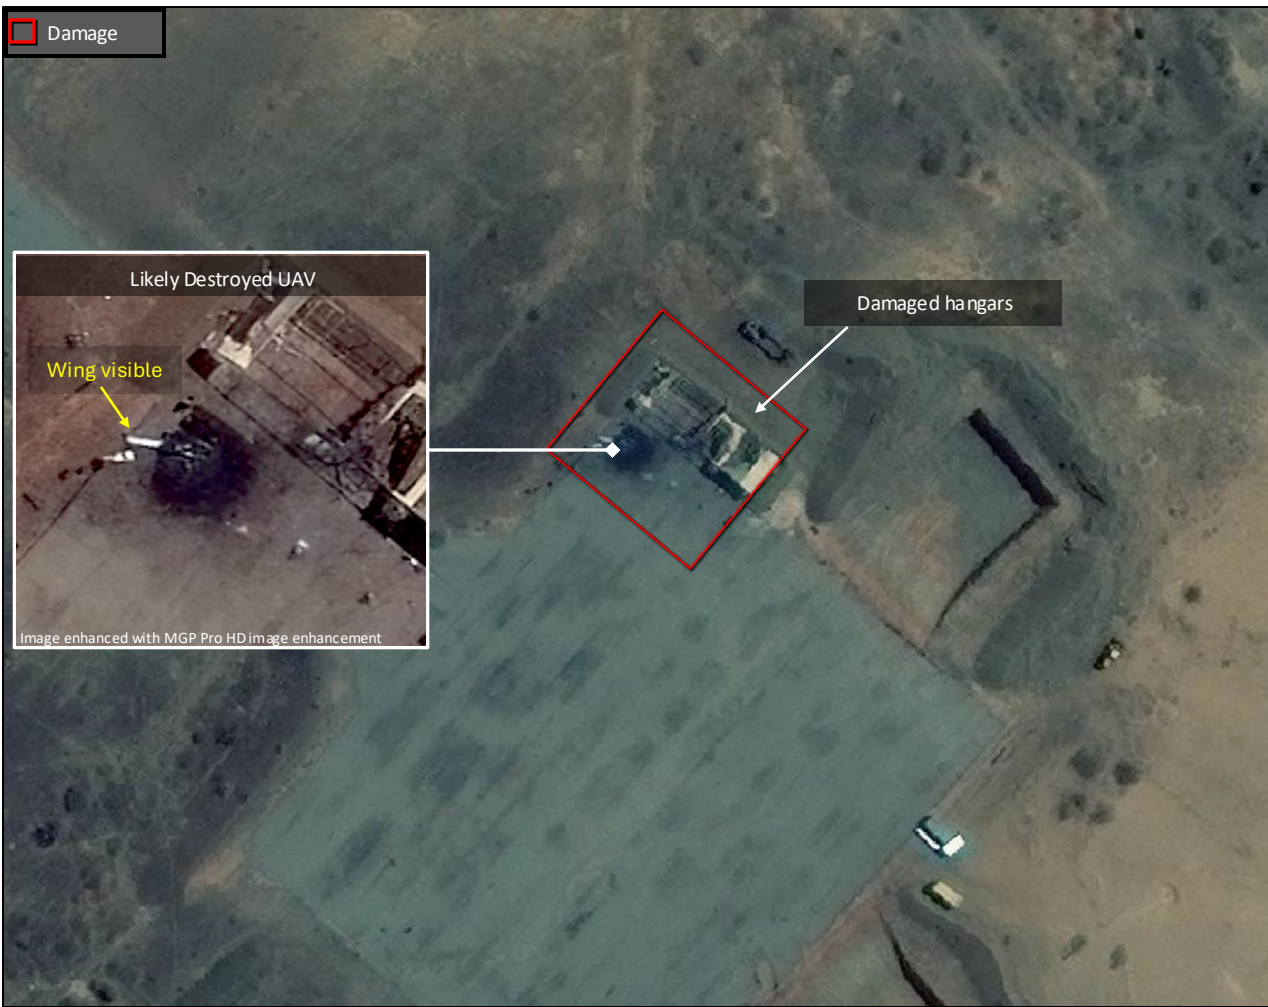
Also observed is the burned wreckage of a likely UAV, with part of the wing still visible. The wing width is consistent with that of a FH-95 or CH-95 UAV, six of which have been previously observed at this airstrip.
